## Access Compliance Report Public Rights-of-Way (Curb Ramps)

Intersection ID: 14846 Main Street: HENLEY\_PL Cross Street: S\_KINGS\_DR Location: SE

ADA ID: 534D1A489BFE Ramp Type: PerpDiag Initial Pass/Fail: Fail Overall Compliance: No Severity Score: 25

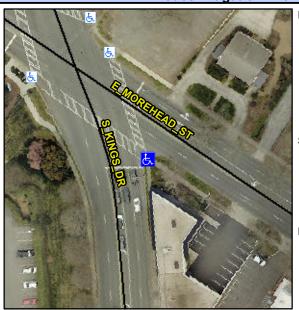
Not Found, R304.2.2

Field Measurements/Component Compnance						
	Compliance Description		Data	Compliance Description		Data
	N/A	Ramp Length (in)	62.0	No	Ramp Slope (%)	12.9
	Yes	Ramp Width (in)	48.0	Yes	Ramp XSlope (%)	1.6
	N/A	Flare Type LT	N/A	N/A	Flare Type RT	N/A
	N/A	Flare Slope LT (%)	N/A	N/A	Flare Slope RT (%)	N/A
	N/A	Flare Traversable LT?	N/A	N/A	Flare Traversable RT?	N/A
	N/A	Landing Length (in)	N/A	N/A	DWS Provided?	N/A
	N/A	Landing Width (in)	N/A	N/A	DWS Contrast?	N/A
	N/A	Landing Slope (%)	N/A	N/A	DWS Length (in)	N/A
	N/A	Landing X Slope (%)	N/A	N/A	DWS Full Width?	N/A
	N/A	Landing Curb? (Y/N)	N/A	N/A	DWS Offset (in)	N/A
	N/A	Shared Landing?	N/A			
	N/A	Gutter Ponding?	N/A	N/A	Gutter Slope (%)	N/A
	N/A	Gutter Lip Ht (in)	N/A	N/A	Gutter X Slope (%)	N/A
	N/A	Painted X Walk1?	Yes	N/A	Painted X Walk2?	Yes
		X Walk 1 Direction	To NE		X Walk 2 Direction	To NW
	N/A	X Walk 1 Width (in)	134.0	N/A	X Walk 2 Width (in)	110.0

X Walk 1 Slope (%)	2.5		X Walk 2 Slope (%)	0.9
		X Walk 1 X Slope (%)	0.5		X Walk 2 X Slope (%)	3.2
	N/A	Ramp inside XWalk1?	Yes	N/A	Ramp inside XWalk2?	Yes
		Road Slope (%)	2.7	N/A	Clear Space?	N/A
		Road X Slope (%)	1.4	N/A	Clear Space to XWalk (in)	N/A

Remove & Replace Curb Ramp With Two New Directional Ramps or Equivalent.
