Access Compliance Report Public Rights-of-Way (Curb Ramps)

Intersection ID: 10033939Main Street: PARK_RDCross Street: N/ALocation:NEADA ID: 53566C792FCCRamp Type: PerpInitial Pass/Fail: FailOverall Compliance: NoSeverity Score:25

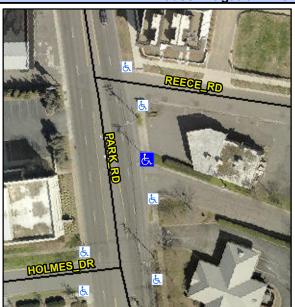
Field Measurements/Component Compilance							
Compl	iance Description	Data	Compl	iance Description	Data		
N/A	Ramp Length (in)	45.0	No	Ramp Slope (%)	15.8		
Yes	Ramp Width (in)	48.0	Yes	Ramp XSlope (%)	1.1		
N/A	Flare Type LT	N/A	N/A	Flare Type RT	N/A		
N/A	Flare Slope LT (%)	N/A	N/A	Flare Slope RT (%)	N/A		
N/A	Flare Traversable LT?	N/A	N/A	Flare Traversable RT?	N/A		
N/A	Landing Length (in)	N/A	N/A	DWS Provided?	N/A		
N/A	Landing Width (in)	N/A	N/A	DWS Contrast?	N/A		
N/A	Landing Slope (%)	N/A	N/A	DWS Length (in)	N/A		
N/A	Landing X Slope (%)	N/A	N/A	DWS Full Width?	N/A		
N/A	Landing Curb? (Y/N)	N/A	N/A	DWS Offset (in)	N/A		
N/A	Shared Landing?	N/A					
N/A	Gutter Ponding?	N/A	N/A	Gutter Slope (%)	N/A		
N/A	Gutter Lip Ht (in)	N/A	N/A	Gutter X Slope (%)	N/A		
N/A	Painted X Walk1?	No	N/A	Painted X Walk2?	N/A		
	X Walk 1 Direction	To S		X Walk 2 Direction	N/A		
N/A	X Walk 1 Width (in)	N/A	N/A	X Walk 2 Width (in)	N/A

Possible Solutions:						
Remove & Replace Entire Ramp.						
Surveyor Notes:						
N/A						
PROW/ADA:						
R304.2.2
