Intersection ID: N/A	Main Street: HUNTER_CREST_LN	Cross Street: WOODLAWN_RD	Location:	SW
ADA ID: 535E9835C101	Ramp Type: PerpDiag	Initial Pass/Fail: Fail	Overall Compliance: No	Severity Score: 25

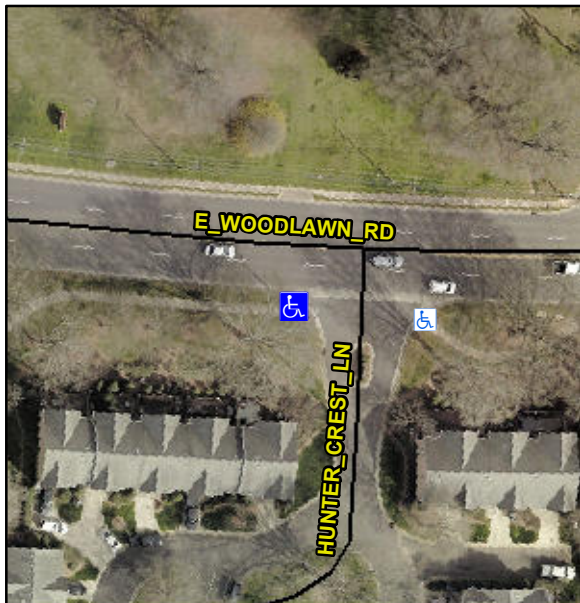
Compliance	Description	Data	Compliance	Description	Data																																																																																												
	N/A	Ramp Length (in)	47.0	Yes	Ramp Slope (%)	5.7																																																																																												
	Yes	Ramp Width (in)	49.0	No	Ramp XSlope (%)	7.1																																																																																												
	N/A	Flare Type LT	N/A	N/A	Flare Type RT	N/A																																																																																												
	N/A	Flare Slope LT (%)	N/A	N/A	Flare Slope RT (%)	N/A																																																																																												
	N/A	Flare Traversable LT?	N/A	N/A	Flare Traversable RT?	N/A																																																																																												
	N/A	Landing Length (in)	N/A	N/A	DWS Provided?	N/A

N/A	Landing Width (in)	N/A	N/A	DWS Contrast?	N/A																																																																																												
	N/A	Landing Slope (%)	N/A	N/A	DWS Length (in)	N/A																																																																																												
N/A	Landing X Slope (%)	N/A	N/A	DWS Full Width?	N/A																																																																																													
Surveyor Notes:	<table><tr><td>N/A</td><td>N/A</td><td>DWS Offset (in)</td><td>N/A</td></tr><tr><td>N/A</td><td>Shared Landing?</td><td>N/A</td><td></td></tr><tr><td>N/A</td><td>Gutter Ponding?</td><td>N/A</td><td>N/A</td><td>Gutter Slope (%)</td><td>N/A</td></tr><tr><td>N/A</td><td>Gutter Lip Ht (in)</td><td>N/A</td><td>N/A</td><td>Gutter X Slope (%)</td><td>N/A</td></tr><tr><td>N/A</td><td>Painted X Walk1?</td><td>No</td><td>N/A</td><td>Painted X Walk2?</td><td>No</td></tr><tr><td></td><td>X Walk 1 Direction</td><td>To E</td><td></td><td>X Walk 2 Direction</td><td>To N</td></tr><tr><td>N/A</td><td>X Walk 1 Width (in)</td><td>N/A</td><td>N/A</td><td>X Walk 2 Width (in)</td><td>N/A</td></tr><tr><td></td><td>X Walk 1 Slope (%)</td><td>1.2</td><td></td><td>X Walk 2 Slope (%)</td><td>7.9</td></tr><tr><td></td><td>X Walk 1 X Slope (%)</td><td>5.9</td><td></td><td>X Walk 2 X Slope (%)</td><td>2.9</td></tr><tr><td>N/A</td><td>Ramp inside XWalk1?</td><td>N/A</td><td>N/A</td><td>Ramp inside XWalk2?</td><td>N/A</td></tr><tr><td></td><td>Road Slope (%)</td><td>6.2</td><td>N/A</td><td>Clear Space?</td><td>N/A</td></tr><tr><td></td><td>Road X Slope (%)</td><td>4.3</td><td>N/A</td><td>Clear Space to XWalk (in)</td><td>N/A</td></tr><tr><td>N/A</td><td>Any Obstructions?</td><td>N/A</td><td>N/A</td><td>Storm Grate/Utility Hazard?</td><td>N/A</td></tr><tr><td></td><td>Obstruction Type</td><td></td><td></td><td>Storm Grate/Utility Type</td><td></td></tr><tr><td></td><td></td><td>N/A</td><td></td><td></td><td>N/A</td></tr><tr><td></td><td></td><td></td><td>Yes</td><td>Surface Condition? (G/P)</td><td>Good</td></tr></table>						N/A	N/A	DWS Offset (in)	N/A	N/A	Shared Landing?	N/A		N/A	Gutter Ponding?	N/A	N/A	Gutter Slope (%)	N/A	N/A	Gutter Lip Ht (in)	N/A	N/A	Gutter X Slope (%)	N/A	N/A	Painted X Walk1?	No	N/A	Painted X Walk2?	No		X Walk 1 Direction	To E		X Walk 2 Direction	To N	N/A	X Walk 1 Width (in)	N/A	N/A	X Walk 2 Width (in)	N/A		X Walk 1 Slope (%)	1.2		X Walk 2 Slope (%)	7.9		X Walk 1 X Slope (%)	5.9		X Walk 2 X Slope (%)	2.9	N/A	Ramp inside XWalk1?	N/A	N/A	Ramp inside XWalk2?	N/A		Road Slope (%)	6.2	N/A	Clear Space?	N/A		Road X Slope (%)	4.3	N/A	Clear Space to XWalk (in)	N/A	N/A	Any Obstructions?	N/A	N/A	Storm Grate/Utility Hazard?	N/A		Obstruction Type			Storm Grate/Utility Type				N/A			N/A				Yes	Surface Condition? (G/P)	Good

N/A	N/A	DWS Offset (in)	N/A																																																																																															
N/A	Shared Landing?	N/A																																																																																																
N/A	Gutter Ponding?	N/A	N/A	Gutter Slope (%)	N/A																																																																																													
N/A	Gutter Lip Ht (in)	N/A	N/A	Gutter X Slope (%)	N/A																																																																																													
N/A	Painted X Walk1?	No	N/A	Painted X Walk2?	No																																																																																													
	X Walk 1 Direction	To E		X Walk 2 Direction	To N																																																																																													
N/A	X Walk 1 Width (in)	N/A	N/A	X Walk 2 Width (in)	N/A

X Walk 1 Slope (%)	1.2		X Walk 2 Slope (%)	7.9																																																																																													
	X Walk 1 X Slope (%)	5.9		X Walk 2 X Slope (%)	2.9																																																																																													
N/A	Ramp inside XWalk1?	N/A	N/A	Ramp inside XWalk2?	N/A																																																																																													
	Road Slope (%)	6.2	N/A	Clear Space?	N/A																																																																																													
	Road X Slope (%)	4.3	N/A	Clear Space to XWalk (in)	N/A																																																																																													
N/A	Any Obstructions?	N/A	N/A	Storm Grate/Utility Hazard?	N/A																																																																																													
	Obstruction Type			Storm Grate/Utility Type

N/A			N/A																																																																																													
			Yes	Surface Condition? (G/P)	Good																																																																																													
PROW/ADA:	Not Found, R304.5.3																																																																																																	
Street 1 Name	HUNTER CREST LN																																																																																																	
Stop Condition-Street 2	StopSign																																																																																																	
Street 2 Name	E WOODLAWN RD																																																																																																	
Stop Condition-Street 1	None																																																																																																	
Total Cost:	\$ 3200.00

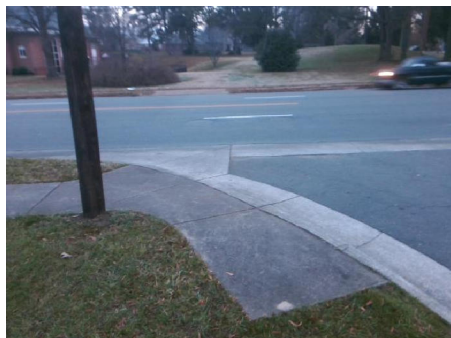
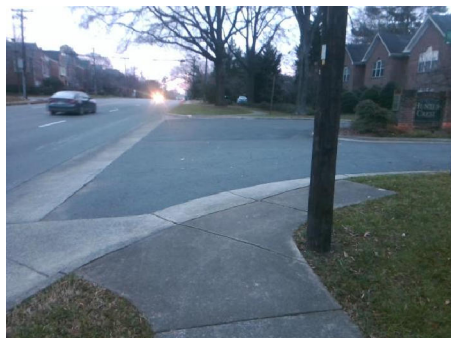
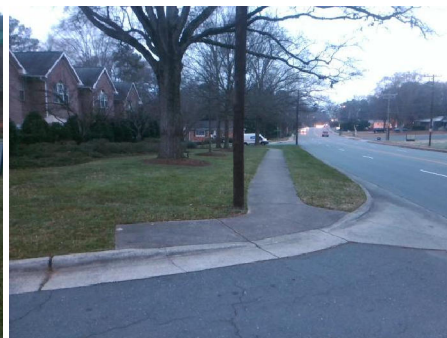
Possible Solutions:	<table><tr><th>Compliance</th><th>Description</th><th>Data</th><th>Compliance</th><th>Description</th><th>Data</th></tr><tr><td>N/A</td><td>Ramp Length (in)</td><td>47.0</td><td>Yes</td><td>Ramp Slope (%)</td><td>5.7</td></tr><tr><td>Yes</td><td>Ramp Width (in)</td><td>49.0</td><td>No</td><td>Ramp XSlope (%)</td><td>7.1</td></tr><tr><td>N/A</td><td>Flare Type LT</td><td>N/A</td><td>N/A</td><td>Flare Type RT</td><td>N/A</td></tr><tr><td>N/A</td><td>Flare Slope LT (%)</td><td>N/A</td><td>N/A</td><td>Flare Slope RT (%)</td><td>N/A</td></tr><tr><td>N/A</td><td>Flare Traversable LT?</td><td>N/A</td><td>N/A</td><td>Flare Traversable RT?</td><td>N/A</td></tr><tr><td>N/A</td><td>Landing Length (in)</td><td>N/A</td><td>N/A</td><td>DWS Provided?</td><td>N/A</td></tr><tr><td>N/A</td><td>Landing Width (in)</td><td>N/A</td><td>N/A</td><td>DWS Contrast?</td><td>N/A</td></tr><tr><td>N/A</td><td>Landing Slope (%)</td><td>N/A</td><td>N/A</td><td>DWS Length (in)</td><td>N/A</td></tr><tr><td>N/A</td><td>Landing X Slope (%)</td><td>N/A</td><td>N/A</td><td>DWS Full Width?</td><td>N/A</td></tr></table>						Compliance	Description	Data	Compliance	Description	Data	N/A	Ramp Length (in)	47.0	Yes	Ramp Slope (%)	5.7	Yes	Ramp Width (in)	49.0	No	Ramp XSlope (%)	7.1	N/A	Flare Type LT	N/A	N/A	Flare Type RT	N/A	N/A	Flare Slope LT (%)	N/A	N/A	Flare Slope RT (%)	N/A	N/A	Flare Traversable LT?	N/A	N/A	Flare Traversable RT?	N/A	N/A	Landing Length (in)	N/A	N/A	DWS Provided?	N/A	N/A	Landing Width (in)	N/A	N/A	DWS Contrast?	N/A	N/A	Landing Slope (%)	N/A	N/A	DWS Length (in)	N/A	N/A	Landing X Slope (%)	N/A	N/A	DWS Full Width?	N/A
