Access Compliance Report

Public Rights-of-Way

(Curb Ramps)

Intersection ID: 30075	Main Street: SOUTHWIND_DR	Cross Street: WOODLANDS_POINTE_DR	Location: NW
ADA ID: 5367CFFA5C56	Ramp Type: BlendTrans1	Initial Pass/Fail: Pass	Overall Compliance: No
Severity Score: 10			
Codes/Mitigation Info/Possible Solution		Field Measurements/Component Compliance

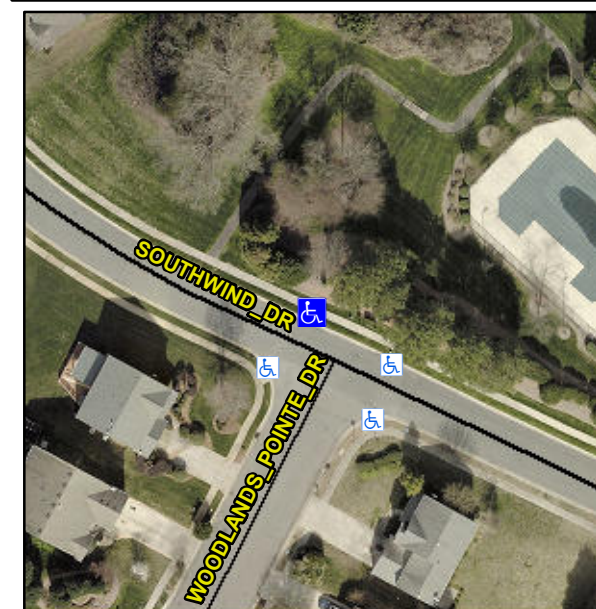
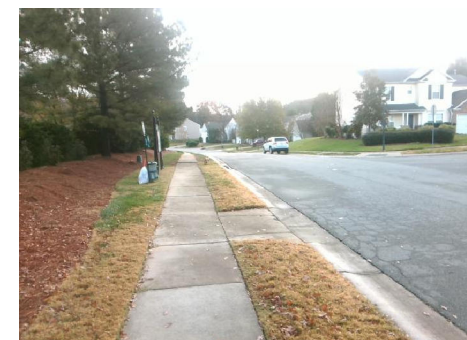
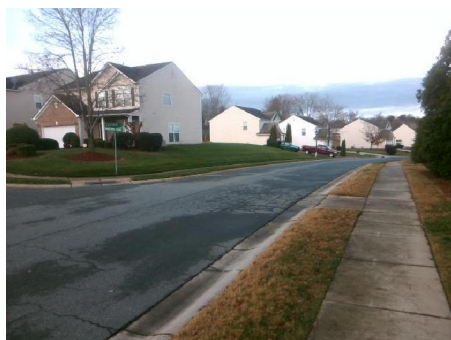
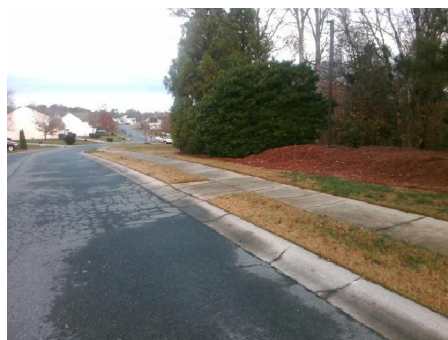
Compliance	Description	Data	Compliance	Description	Data
N/A	Ramp Length (in)	46.5	Yes	BlendTrans Slope (%)	3.2
Yes	Ramp Width (in)	49.0	Yes	BlendTrans XSlope (%)	1.0
N/A	Flare Type LT	Sloped	N/A	Flare Type RT	Sloped
N/A	Flare Slope LT (%)	2.4	N/A	Flare Slope RT (%)	2.2
N/A	Flare Traversable LT?	No	N/A	Flare Traversable RT?	No
No	Landing Length (in)	47.5	No	DWS Provided?	No
Yes	Landing Width (in)	49.0	N/A	DWS Contrast?	No
Yes	Landing Slope (%)	1.2	N/A	DWS Length (in)	N/A
Yes	Landing X Slope (%)	0.9	N/A	DWS Full Width?	No
N/A	Landing Curb? (Y/N)	No	N/A	DWS Offset (in)	N/A
N/A	Shared Landing?	No			
Yes	Gutter Ponding?	No	Yes	Gutter Slope (%)	1.3
Yes	Gutter Lip Ht (in)	0.0	Yes	Gutter X Slope (%)	1.2
N/A	Painted X Walk1?	No	N/A	Painted X Walk2?	N/A
	X Walk 1 Direction	To SW		X Walk 2 Direction	N/A
	X Walk 1 Width (in)	N/A		X Walk 2 Width (in)	N/A
	X Walk 1 Slope (%)	0.9		X Walk 2 Slope (%)	N/A
	X Walk 1 X Slope (%)	1.3		X Walk 2 X Slope (%)	N/A

N/A	Ramp inside XWalk1?	N/A	N/A	Ramp inside XWalk2?	N/A
	Road Slope (%)	1.3		Clear Space?	Yes
	Road X Slope (%)	0.9	N/A	Clear Space to XWalk (in)	N/A
Yes	Any Obstructions?	No	Yes	Storm Grate/Utility Hazard?	No
	Obstruction Type			Storm Grate/Utility Type	
		N/A			N/A
			Yes	Surface Condition? (G/P)	Good
			No	Curb Slope (%)	6.3

Possible Solutions:

Remove & Replace Curb Ramp With Two New Directional Ramps or Equivalent.

Not Found, R304.2.1, R305
