Access Compliance Report

Public Rights-of-Way

(Curb Ramps)

Intersection ID: 10037850	Main Street: SHARON_RD	Cross Street: N/A	Location: SW
ADA ID: 536AA1A416F6	Ramp Type: MedianPerp	Initial Pass/Fail: Fail	Overall Compliance: No
		Severity Score: 10

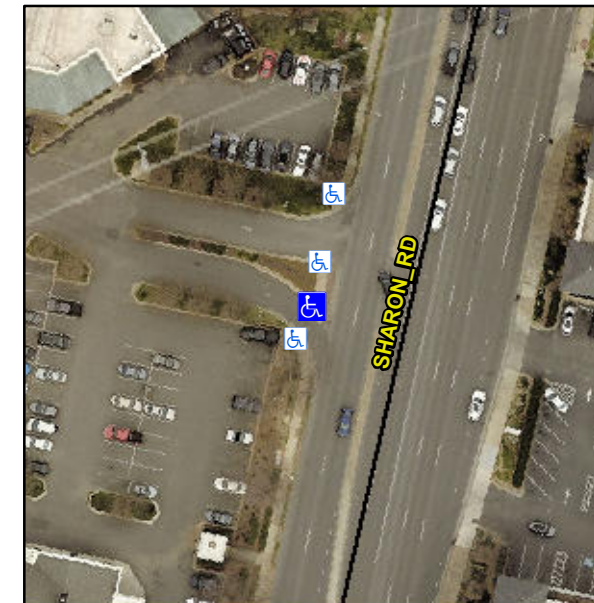
Not Found, R304.5.1, R304.5.3

Compliance	Description	Data	Compliance	Description	Data
N/A	Ramp Length (in)	72.0	Yes	Ramp Slope (%)	5.2
No	Ramp Width (in)	45.0	No	Ramp XSlope (%)	2.4
N/A	Flare Type LT	N/A	N/A	Flare Type RT	N/A
N/A	Flare Slope LT (%)	N/A	N/A	Flare Slope RT (%)	N/A
N/A	Flare Traversable LT?	N/A	N/A	Flare Traversable RT?	N/A
N/A	Landing Length (in)	N/A	N/A	DWS Provided?	N/A
N/A	Landing Width (in)	N/A	N/A	DWS Contrast?	N/A
N/A	Landing Slope (%)	N/A	N/A	DWS Length (in)	N/A
N/A	Landing X Slope (%)	N/A	N/A	DWS Full Width?	N/A
N/A	Landing Curb? (Y/N)	N/A	N/A	DWS Offset (in)	N/A
N/A	Shared Landing?	N/A			
N/A	Gutter Ponding?	N/A	N/A	Gutter Slope (%)	N/A
N/A	Gutter Lip Ht (in)	N/A	N/A	Gutter X Slope (%)	N/A
N/A	Painted X Walk1?	No	N/A	Painted X Walk2?	N/A
	X Walk 1 Direction	To S		X Walk 2 Direction	N/A
N/A	X Walk 1 Width (in)	N/A	N/A	X Walk 2 Width (in)	N/A
	X Walk 1 Slope (%)	1.3		X Walk 2 Slope (%)	N/A
	X Walk 1 X Slope (%)	0.3		X Walk 2 X Slope (%)	N/A

N/A	Ramp inside XWalk1?	N/A	N/A	Ramp inside XWalk2?	N/A
	Road Slope (%)	N/A	N/A	Clear Space?	N/A
	Road X Slope (%)	N/A	N/A	Clear Space to XWalk (in)	N/A
N/A	Any Obstructions?	N/A	N/A	Storm Grate/Utility Hazard?	N/A
	Obstruction Type			Storm Grate/Utility Type	
		N/A			N/A
			Yes	Surface Condition? (G/P)	Good

Remove & Replace Entire Ramp.
