# Access Compliance Report

## Public Rights-of-Way

### (Curb Ramps)

Intersection ID: 16680	Main Street: NORTH_FALLS_DR	Cross Street: WATER_RIDGE_PY	Location: SE
ADA ID: 536B08E80AF4	Ramp Type: PerpDiag	Initial Pass/Fail: Fail	Overall Compliance: No
Severity Score: 37.5			
Codes/Mitigation Info/Possible Solution		Field Measurements/Component Compliance

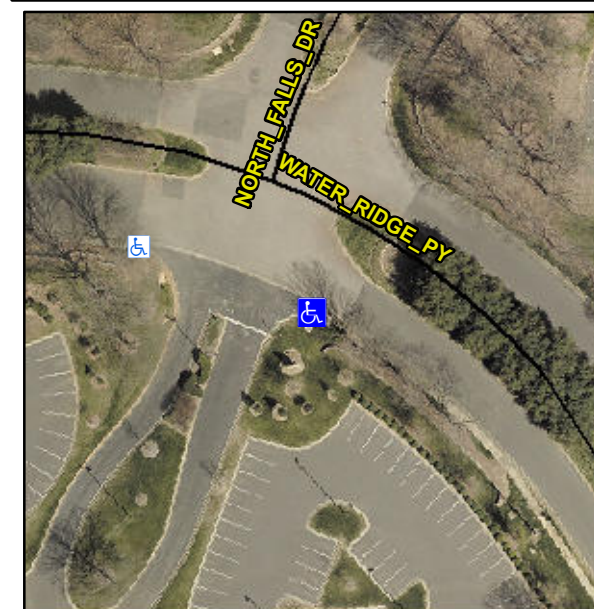
**Not Found, R304.2.2, R304.5.3**

Compliance	Description	Data	Compliance	Description	Data
N/A	Ramp Length (in)	67.0	No	Ramp Slope (%)	11.6
Yes	Ramp Width (in)	53.0	No	Ramp XSlope (%)	10.0
N/A	Flare Type LT	N/A	N/A	Flare Type RT	N/A
N/A	Flare Slope LT (%)	N/A	N/A	Flare Slope RT (%)	N/A
N/A	Flare Traversable LT?	N/A	N/A	Flare Traversable RT?	N/A
N/A	Landing Length (in)	N/A	N/A	DWS Provided?	N/A
N/A	Landing Width (in)	N/A	N/A	DWS Contrast?	N/A
N/A	Landing Slope (%)	N/A	N/A	DWS Length (in)	N/A
N/A	Landing X Slope (%)	N/A	N/A	DWS Full Width?	N/A
N/A	Landing Curb? (Y/N)	N/A	N/A	DWS Offset (in)	N/A
N/A	Shared Landing?	N/A			
N/A	Gutter Ponding?	N/A	N/A	Gutter Slope (%)	N/A
N/A	Gutter Lip Ht (in)	N/A	N/A	Gutter X Slope (%)	N/A
N/A	Painted X Walk1?	No	N/A	Painted X Walk2?	No
	X Walk 1 Direction	To N		X Walk 2 Direction	To W
N/A	X Walk 1 Width (in)	N/A	N/A	X Walk 2 Width (in)	N/A
	X Walk 1 Slope (%)	3.3		X Walk 2 Slope (%)	6.1
	X Walk 1 X Slope (%)	5.7		X Walk 2 X Slope (%)	5.0

N/A	Ramp inside XWalk1?	N/A	N/A	Ramp inside XWalk2?	N/A
	Road Slope (%)	8.8	N/A	Clear Space?	N/A
	Road X Slope (%)	2.6	N/A	Clear Space to XWalk (in)	N/A
N/A	Any Obstructions?	N/A	N/A	Storm Grate/Utility Hazard?	N/A
	Obstruction Type			Storm Grate/Utility Type	
		N/A			N/A
		Yes		Surface Condition? (G/P)	Good

**Remove & Replace Curb Ramp With Two New Directional Ramps or Equivalent.**
