# Access Compliance Report

## Public Rights-of-Way

### (Curb Ramps)

Intersection ID: 11842	Main Street: CAGLE_AV	Cross Street: N_SHARON_AMITY_RD	Location: SE
ADA ID: 536D3CFC9DE5	Ramp Type: Perp	Initial Pass/Fail: Fail	Overall Compliance: No
Severity Score: 1.25			
Codes/Mitigation Info/Possible Solution		Field Measurements/Component Compliance

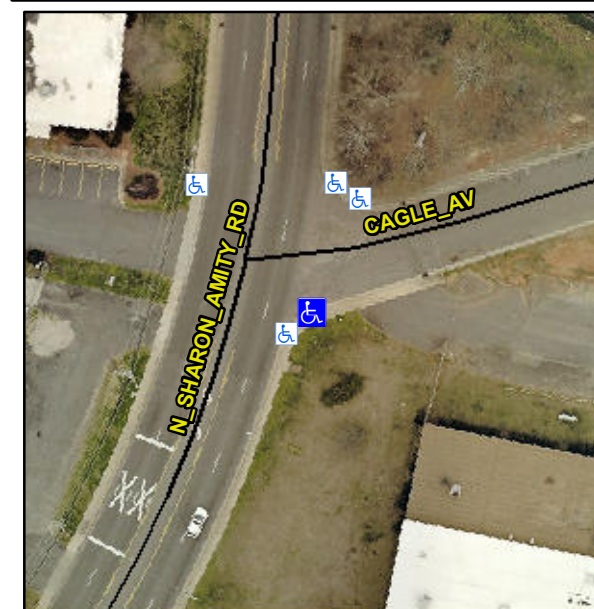
**Not Found, R304.5.3**

Compliance	Description	Data	Compliance	Description	Data
N/A	Ramp Length (in)	64.5	Yes	Ramp Slope (%)	8.2
Yes	Ramp Width (in)	92.0	No	Ramp XSlope (%)	3.3
N/A	Flare Type LT	N/A	N/A	Flare Type RT	N/A
N/A	Flare Slope LT (%)	N/A	N/A	Flare Slope RT (%)	N/A
N/A	Flare Traversable LT?	N/A	N/A	Flare Traversable RT?	N/A
N/A	Landing Length (in)	N/A	N/A	DWS Provided?	N/A
N/A	Landing Width (in)	N/A	N/A	DWS Contrast?	N/A
N/A	Landing Slope (%)	N/A	N/A	DWS Length (in)	N/A
N/A	Landing X Slope (%)	N/A	N/A	DWS Full Width?	N/A
N/A	Landing Curb? (Y/N)	N/A	N/A	DWS Offset (in)	N/A
N/A	Shared Landing?	N/A			
N/A	Gutter Ponding?	N/A	N/A	Gutter Slope (%)	N/A
N/A	Gutter Lip Ht (in)	N/A	N/A	Gutter X Slope (%)	N/A
N/A	Painted X Walk1?	No	N/A	Painted X Walk2?	N/A
	X Walk 1 Direction	To NE		X Walk 2 Direction	N/A
N/A	X Walk 1 Width (in)	N/A	N/A	X Walk 2 Width (in)	N/A
	X Walk 1 Slope (%)	0.2		X Walk 2 Slope (%)	N/A
	X Walk 1 X Slope (%)	0.1		X Walk 2 X Slope (%)	N/A

**Remove & Replace Entire Ramp.**

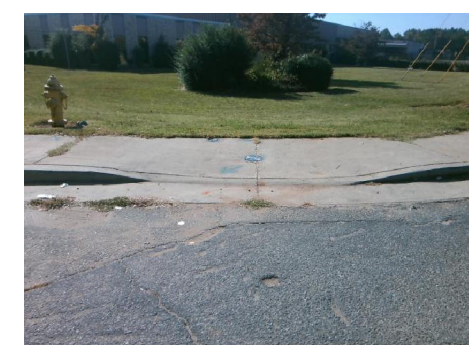
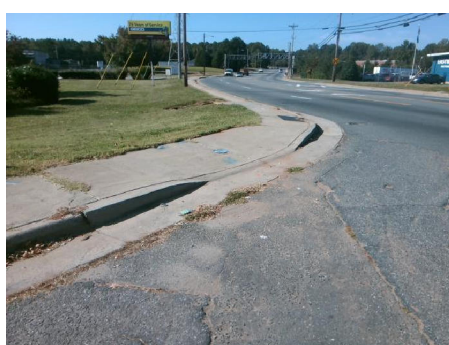
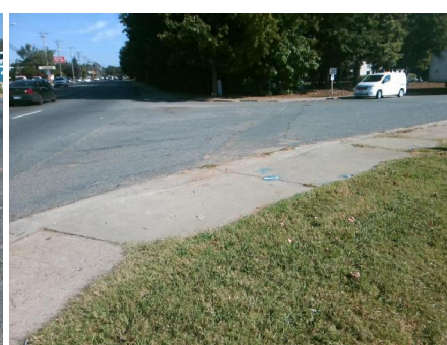
N/A	Ramp inside XWalk1?	N/A	N/A	Ramp inside XWalk2?	N/A
	Road Slope (%)	N/A	N/A	Clear Space?	N/A
	Road X Slope (%)	N/A	N/A	Clear Space to XWalk (in)	N/A
N/A	Any Obstructions?	N/A	N/A	Storm Grate/Utility Hazard?	N/A
	Obstruction Type			Storm Grate/Utility Type	
		N/A			N/A
			Yes	Surface Condition? (G/P)	Good
