Access Compliance Report

Public Rights-of-Way

(Curb Ramps)

Intersection ID: 12110	Main Street: S_MINT_ST	Cross Street: W_4TH_ST	Location: W
ADA ID: 5378A507511F	Ramp Type: Perp	Initial Pass/Fail: Fail	Overall Compliance: No
Severity Score: 22.5			
Codes/Mitigation Info/Possible Solution		Field Measurements/Component Compliance

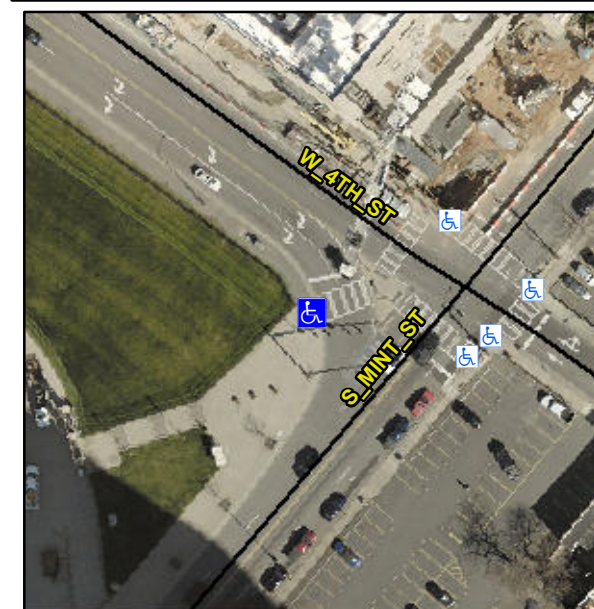
Not Found, R304.5.1, R304.2.2

Compliance	Description	Data	Compliance	Description	Data
N/A	Ramp Length (in)	78.0	No	Ramp Slope (%)	9.0
No	Ramp Width (in)	47.5	Yes	Ramp XSlope (%)	2.8
N/A	Flare Type LT	N/A	N/A	Flare Type RT	N/A
N/A	Flare Slope LT (%)	N/A	N/A	Flare Slope RT (%)	N/A
N/A	Flare Traversable LT?	N/A	N/A	Flare Traversable RT?	N/A
N/A	Landing Length (in)	N/A	N/A	DWS Provided?	N/A
N/A	Landing Width (in)	N/A	N/A	DWS Contrast?	N/A
N/A	Landing Slope (%)	N/A	N/A	DWS Length (in)	N/A
N/A	Landing X Slope (%)	N/A	N/A	DWS Full Width?	N/A
N/A	Landing Curb? (Y/N)	N/A	N/A	DWS Offset (in)	N/A
N/A	Shared Landing?	N/A			
N/A	Gutter Ponding?	N/A	N/A	Gutter Slope (%)	N/A
N/A	Gutter Lip Ht (in)	N/A	N/A	Gutter X Slope (%)	N/A
N/A	Painted X Walk1?	Yes	N/A	Painted X Walk2?	N/A
	X Walk 1 Direction	To E		X Walk 2 Direction	N/A
N/A	X Walk 1 Width (in)	158.0	N/A	X Walk 2 Width (in)	N/A
	X Walk 1 Slope (%)	3.8		X Walk 2 Slope (%)	N/A
	X Walk 1 X Slope (%)	3.2		X Walk 2 X Slope (%)	N/A

N/A	Ramp inside XWalk1?	Yes	N/A	Ramp inside XWalk2?	N/A
	Road Slope (%)	N/A	N/A	Clear Space?	N/A
	Road X Slope (%)	N/A	N/A	Clear Space to XWalk (in)	N/A
N/A	Any Obstructions?	N/A	N/A	Storm Grate/Utility Hazard?	N/A
	Obstruction Type			Storm Grate/Utility Type	
		N/A			N/A
			Yes	Surface Condition? (G/P)	Good

Remove & Replace Entire Ramp.
