# Access Compliance Report

## Public Rights-of-Way

### (Curb Ramps)

Intersection ID: 12728	Main Street: E_10TH_ST	Cross Street: SEIGLE_AV	Location: S
ADA ID: 537AD1DD754F	Ramp Type: PerpDiag	Initial Pass/Fail: Fail	Overall Compliance: No
		Severity Score: 50

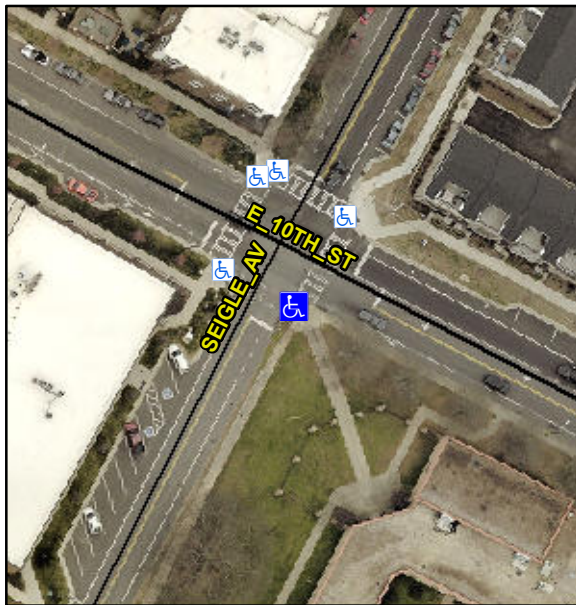
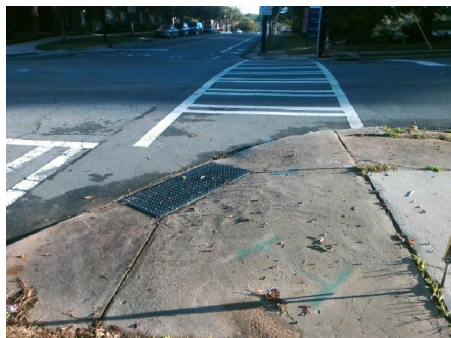
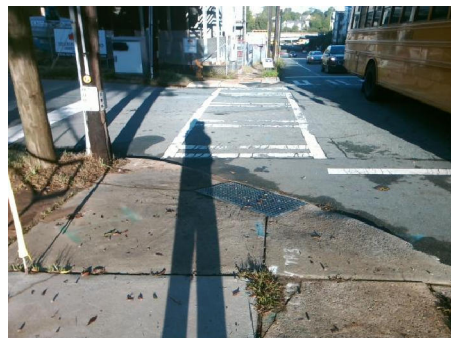
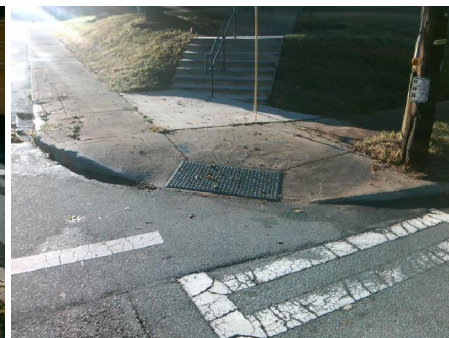
Compliance	Description	Data	Compliance	Description	Data
N/A	Ramp Length (in)	47.0	No	Ramp Slope (%)	12.0
Yes	Ramp Width (in)	60.0	No	Ramp XSlope (%)	8.0
N/A	Flare Type LT	N/A	N/A	Flare Type RT	N/A
N/A	Flare Slope LT (%)	N/A	N/A	Flare Slope RT (%)	N/A
N/A	Flare Traversable LT?	N/A	N/A	Flare Traversable RT?	N/A
N/A	Landing Length (in)	N/A	N/A	DWS Provided?	N/A
N/A	Landing Width (in)	N/A	N/A	DWS Contrast?	N/A
N/A	Landing Slope (%)	N/A	N/A	DWS Length (in)	N/A
N/A	Landing X Slope (%)	N/A	N/A	DWS Full Width?	N/A
N/A	Landing Curb? (Y/N)	N/A	N/A	DWS Offset (in)	N/A
N/A	Shared Landing?	N/A			
N/A	Gutter Ponding?	N/A	N/A	Gutter Slope (%)	N/A
N/A	Gutter Lip Ht (in)	N/A	N/A	Gutter X Slope (%)	N/A
N/A	Painted X Walk1?	Yes	N/A	Painted X Walk2?	Yes
	X Walk 1 Direction	To NE		X Walk 2 Direction	To NW
N/A	X Walk 1 Width (in)	110.0	N/A	X Walk 2 Width (in)	87.0
	X Walk 1 Slope (%)	6.2		X Walk 2 Slope (%)	0.2
	X Walk 1 X Slope (%)	2.5		X Walk 2 X Slope (%)	6.3

N/A	Ramp inside XWalk1?	Yes	N/A	Ramp inside XWalk2?	Yes
	Road Slope (%)	6.0	N/A	Clear Space?	N/A
	Road X Slope (%)	4.0	N/A	Clear Space to XWalk (in)	N/A
N/A	Any Obstructions?	N/A	N/A	Storm Grate/Utility Hazard?	N/A
	Obstruction Type			Storm Grate/Utility Type	
		N/A			N/A
		Yes		Surface Condition? (G/P)	Good

**Remove & Replace Curb Ramp With Two New Directional Ramps or Equivalent.**

**R304.2.2, R304.5.3**
