Access Compliance Report

Public Rights-of-Way

(Curb Ramps)

Intersection ID: 52442		Main Street: WOODWARD_AV		Cross Street: BENDING_BIRCH_PL		Location: NE											
ADA ID: 538238F4C007		Ramp Type: Directional1		Initial Pass/Fail: Fail		Overall Compliance: No		Severity Score: 12.5									
Codes/Mitigation Info/Possible Solution				Field Measurements/Component Compliance													
<div>

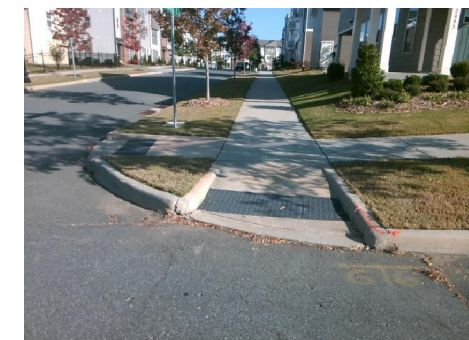
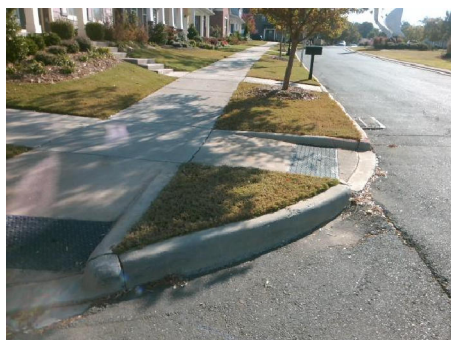
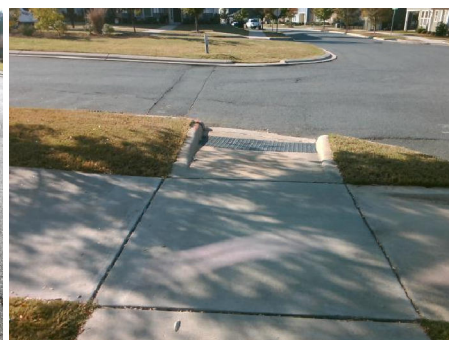
X Walk 1 Width (in)		N/A				Clear Space?		N/A			
						X Walk 1 Slope (%)		5.5		N/A		Clear Space to XWalk (in)		N/A			
						X Walk 1 X Slope (%)		0.1		N/A		Storm Grate/Utility Hazard?		N/A			
				N/A		Ramp inside XWalk1?		N/A				Storm Grate/Utility Type					
				N/A		Any Obstructions?		N/A						N/A			
						Obstruction Type				Yes		Surface Condition? (G/P)		Good			
										N/A		N/A		Curb Slope (%)		1.2
