Intersection ID: 11916	Main Street: DUBLIN_RD	Cross Street: WESTERLY_HILLS_DR	Location:	N
ADA ID: 5390B1D7941F	Ramp Type: Perp	Initial Pass/Fail: Fail	Overall Compliance: No	Severity Score: 22.5

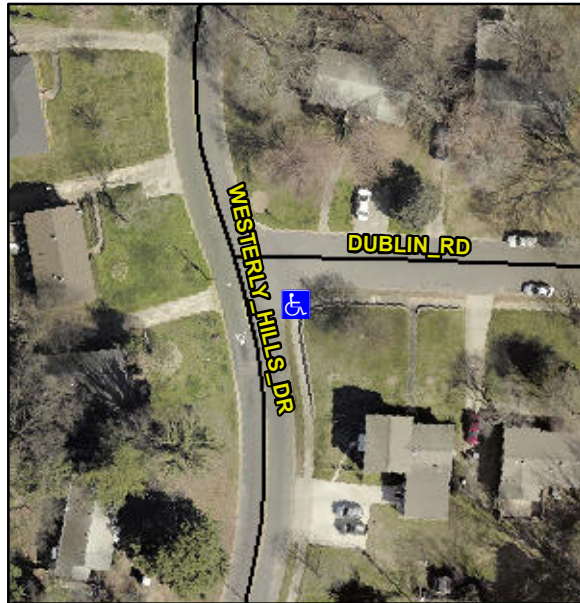
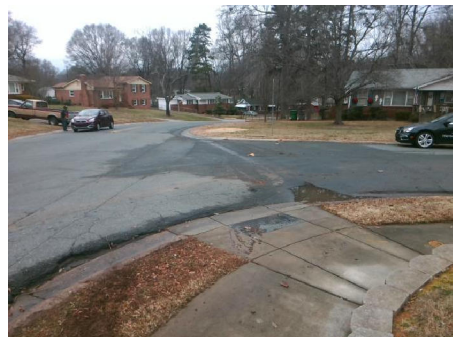
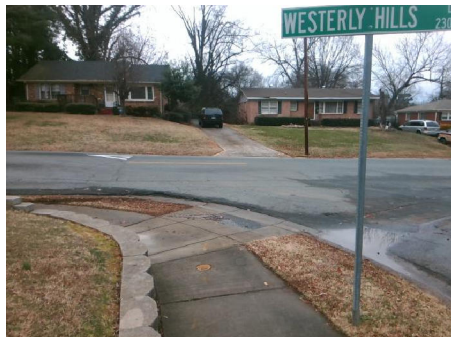
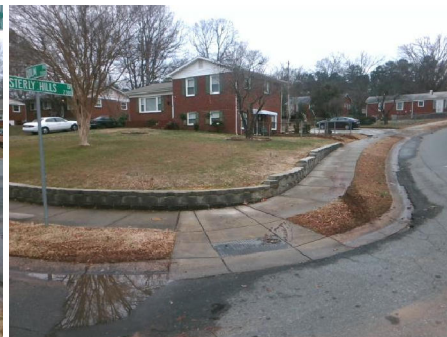
**Not Found, R304.5.1, R304.2.2,
R304.5.3**

Possible Solutions:			Compliance	Description	Data	Compliance	Description	Data
Remove & Replace Entire Ramp.	N/A	Ramp Length (in)	49.0	No	Ramp Slope (%)	10.0		
	No	Ramp Width (in)	45.0	No	Ramp XSlope (%)	2.2		
	N/A	Flare Type LT	N/A	N/A	Flare Type RT	N/A		
	N/A	Flare Slope LT (%)	N/A	N/A	Flare Slope RT (%)	N/A		
	N/A	Flare Traversable LT?	N/A	N/A	Flare Traversable RT?	N/A		
	N/A	Landing Length (in)	N/A	N/A	DWS Provided?	N/A		
	N/A	Landing Width (in)	N/A	N/A	DWS Contrast?	N/A		
	N/A	Landing Slope (%)	N/A	N/A	DWS Length (in)	N/A		
	N/A	Landing X Slope (%)	N/A	N/A	DWS Full Width?	N/A		
	N/A	Landing Curb? (Y/N)	N/A	N/A	DWS Offset (in)	N/A		
Surveyor Notes: N/A	N/A	Shared Landing?	N/A					
	N/A	Gutter Ponding?	N/A	N/A	Gutter Slope (%)	N/A		
	N/A	Gutter Lip Ht (in)	1.0	N/A	Gutter X Slope (%)	N/A		
	N/A	Painted X Walk1?	No	N/A	Painted X Walk2?	N/A		
		X Walk 1 Direction	To S		X Walk 2 Direction	N/A		
	N/A	X Walk 1 Width (in)	N/A	N/A	X Walk 2 Width (in)	N/A

X Walk 1 Slope (%)	1.1		X Walk 2 Slope (%)	N/A		
		X Walk 1 X Slope (%)	4.2		X Walk 2 X Slope (%)	N/A		
	N/A	Ramp inside XWalk1?	N/A	N/A	Ramp inside XWalk2?	N/A		
		Road Slope (%)	4.2	N/A	Clear Space?	N/A		
PROW/ADA: Not Found, R304.5.1, R304.2.2, R304.5.3		Road X Slope (%)	1.1	N/A	Clear Space to XWalk (in)	N/A		
	N/A	Any Obstructions?	N/A	N/A	Storm Grate/Utility Hazard?	N/A		
		Obstruction Type			Storm Grate/Utility Type			
			N/A			N/A		
				Yes	Surface Condition? (G/P)	Good		
	Total Cost:	\$	1850.00

Remove & Replace Entire Ramp.
