Access Compliance Report

Public Rights-of-Way

(Curb Ramps)

Intersection ID: 53292	Main Street: PROSPERITY RIDGE RD	Cross Street: ROBERT HELMS RD	Location: W
ADA ID: 53910BA2336D	Ramp Type: Perp	Initial Pass/Fail: Fail	Overall Compliance: No
Severity Score: 12.5			
Codes/Mitigation Info/Possible Solution		Field Measurements/Component Compliance

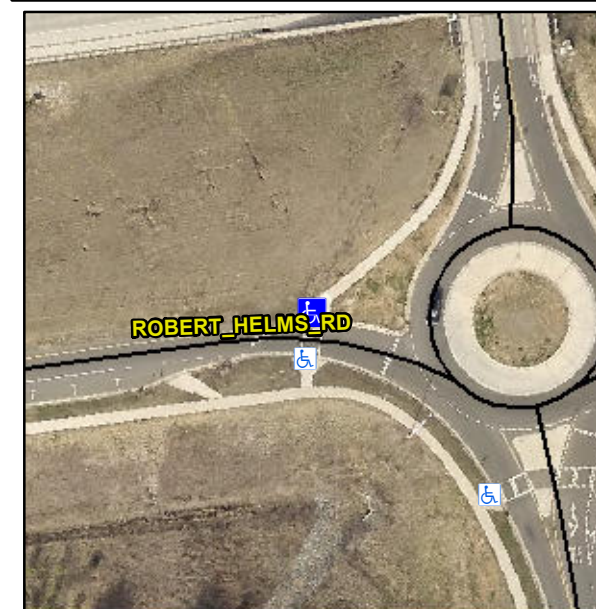
Compliance	Description	Data	Compliance	Description	Data
N/A	Ramp Length (in)	91.0	Yes	Ramp Slope (%)	7.1
Yes	Ramp Width (in)	48.0	No	Ramp XSlope (%)	5.1
N/A	Flare Type LT	N/A	N/A	Flare Type RT	N/A
N/A	Flare Slope LT (%)	N/A	N/A	Flare Slope RT (%)	N/A
N/A	Flare Traversable LT?	N/A	N/A	Flare Traversable RT?	N/A
N/A	Landing Length (in)	N/A	N/A	DWS Provided?	N/A
N/A	Landing Width (in)	N/A	N/A	DWS Contrast?	N/A
N/A	Landing Slope (%)	N/A	N/A	DWS Length (in)	N/A
N/A	Landing X Slope (%)	N/A	N/A	DWS Full Width?	N/A
N/A	Landing Curb? (Y/N)	N/A	N/A	DWS Offset (in)	N/A
N/A	Shared Landing?	N/A			
N/A	Gutter Ponding?	N/A	N/A	Gutter Slope (%)	N/A
N/A	Gutter Lip Ht (in)	N/A	N/A	Gutter X Slope (%)	N/A
N/A	Painted X Walk1?	Yes	N/A	Painted X Walk2?	N/A
	X Walk 1 Direction	To S		X Walk 2 Direction	N/A
N/A	X Walk 1 Width (in)	103.0	N/A	X Walk 2 Width (in)	N/A
	X Walk 1 Slope (%)	1.8		X Walk 2 Slope (%)	N/A
	X Walk 1 X Slope (%)	1.4		X Walk 2 X Slope (%)	N/A

N/A	Ramp inside XWalk1?	Yes	N/A	Ramp inside XWalk2?	N/A
	Road Slope (%)	N/A	N/A	Clear Space?	N/A
	Road X Slope (%)	N/A	N/A	Clear Space to XWalk (in)	N/A
N/A	Any Obstructions?	N/A	N/A	Storm Grate/Utility Hazard?	N/A
	Obstruction Type			Storm Grate/Utility Type	
		N/A			N/A
		Yes		Surface Condition? (G/P)	Good

Possible Solutions:

Remove & Replace Entire Ramp.

PROW/ADA:

R304.5.3
