# Access Compliance Report

## Public Rights-of-Way

### (Curb Ramps)

Intersection ID: N/A	Main Street: E MARTIN LUTHER KING JR BV	Cross Street: S CALDWELL ST	Location: SE
ADA ID: 53998B760593	Ramp Type: Perp	Initial Pass/Fail: Fail	Overall Compliance: No
Severity Score: 12.5			
Codes/Mitigation Info/Possible Solution		Field Measurements/Component Compliance

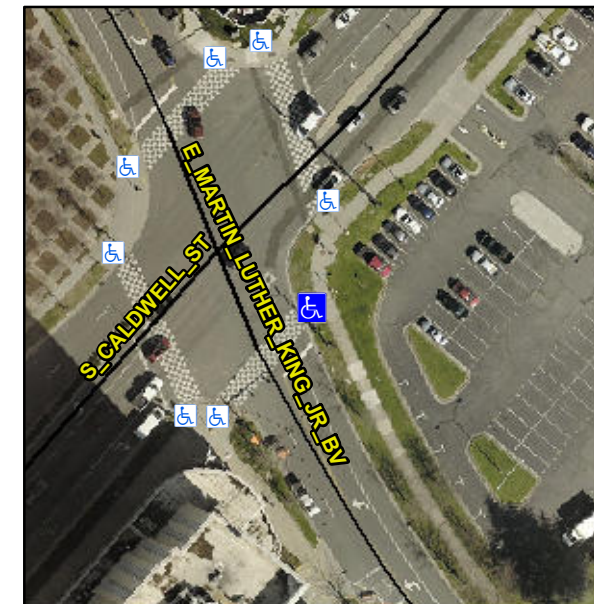
**Not Found, R304.5.3**

Compliance	Description	Data	Compliance	Description	Data
N/A	Ramp Length (in)	110.0	Yes	Ramp Slope (%)	6.4
Yes	Ramp Width (in)	48.0	No	Ramp XSlope (%)	5.1
N/A	Flare Type LT	N/A	N/A	Flare Type RT	N/A
N/A	Flare Slope LT (%)	N/A	N/A	Flare Slope RT (%)	N/A
N/A	Flare Traversable LT?	No	N/A	Flare Traversable RT?	No
N/A	Landing Length (in)	N/A	N/A	DWS Provided?	N/A
N/A	Landing Width (in)	N/A	N/A	DWS Contrast?	N/A
N/A	Landing Slope (%)	N/A	N/A	DWS Length (in)	N/A
N/A	Landing X Slope (%)	N/A	N/A	DWS Full Width?	N/A
N/A	Landing Curb? (Y/N)	N/A	N/A	DWS Offset (in)	N/A
N/A	Shared Landing?	N/A			
N/A	Gutter Ponding?	N/A	N/A	Gutter Slope (%)	N/A
N/A	Gutter Lip Ht (in)	N/A	N/A	Gutter X Slope (%)	N/A
N/A	Painted X Walk1?	Yes	N/A	Painted X Walk2?	N/A
	X Walk 1 Direction	To SW		X Walk 2 Direction	N/A
N/A	X Walk 1 Width (in)	144.0	N/A	X Walk 2 Width (in)	N/A
	X Walk 1 Slope (%)	0.5		X Walk 2 Slope (%)	N/A
	X Walk 1 X Slope (%)	4.1		X Walk 2 X Slope (%)	N/A

N/A	Ramp inside XWalk1?	Yes	N/A	Ramp inside XWalk2?	N/A
	Road Slope (%)	N/A	N/A	Clear Space?	N/A
	Road X Slope (%)	N/A	N/A	Clear Space to XWalk (in)	N/A
N/A	Any Obstructions?	N/A	N/A	Storm Grate/Utility Hazard?	N/A
	Obstruction Type			Storm Grate/Utility Type	
		N/A			N/A
		Yes		Surface Condition? (G/P)	Good

**Remove & Replace Entire Ramp.**

Total Cost: \$ 1850.00
