Intersection ID: 44723	Main Street: PROSPERITY_CHURCH_RD	Cross Street: JOHNSTON_OEHLE_R	Location:	SW
ADA ID: 53A6DA2656D6	Ramp Type: Perp	Initial Pass/Fail: Fail	Overall Compliance: No	Severity Score: 48.75

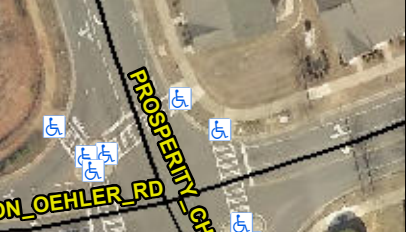
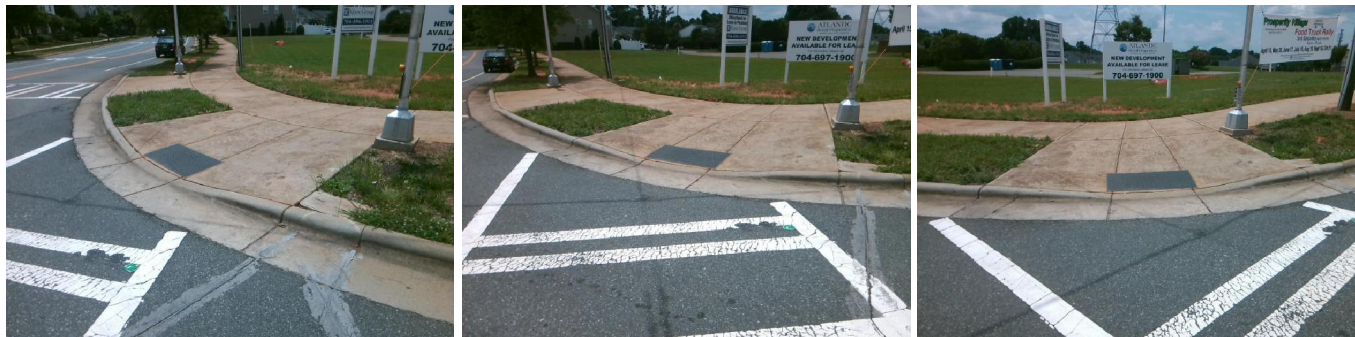
Possible Solutions:		Compliance	Description	Data	Compliance	Description	Data
	Remove & Replace Entire Ramp.		N/A	Ramp Length (in)	96.0	No	Ramp Slope (%)	9.4
			No	Ramp Width (in)	30.0	No	Ramp XSlope (%)	3.9
			N/A	Flare Type LT	N/A	N/A	Flare Type RT	N/A
			N/A	Flare Slope LT (%)	N/A	N/A	Flare Slope RT (%)	N/A
			N/A	Flare Traversable LT?	N/A	N/A	Flare Traversable RT?	N/A
			N/A	Landing Length (in)	N/A	N/A	DWS Provided?	N/A
			N/A	Landing Width (in)	N/A	N/A	DWS Contrast?	N/A
			N/A	Landing Slope (%)	N/A	N/A	DWS Length (in)	N/A
			N/A	Landing X Slope (%)	N/A	N/A	DWS Full Width?	N/A
Surveyor Notes: N/A			N/A	Landing Curb? (Y/N)	N/A	N/A	DWS Offset (in)	N/A
			N/A	Shared Landing?	N/A			
			N/A	Gutter Ponding?	N/A	N/A	Gutter Slope (%)	N/A
			N/A	Gutter Lip Ht (in)	N/A	N/A	Gutter X Slope (%)	N/A
			N/A	Painted X Walk1?	Yes	N/A	Painted X Walk2?	N/A

X Walk 1 Direction	To N		X Walk 2 Direction	N/A
			N/A	X Walk 1 Width (in)	112.0	N/A	X Walk 2 Width (in)	N/A
				X Walk 1 Slope (%)	5.6		X Walk 2 Slope (%)	N/A
				X Walk 1 X Slope (%)	3.3		X Walk 2 X Slope (%)	N/A
			N/A	Ramp inside XWalk1?	Yes	N/A	Ramp inside XWalk2?	N/A
PROW/ADA: R304.5.1, R304.2.2, R304.5.3				Road Slope (%)	N/A	N/A	Clear Space?	N/A
				Road X Slope (%)	N/A	N/A	Clear Space to XWalk (in)	N/A
			N/A	Any Obstructions?	N/A	N/A	Storm Grate/Utility Hazard?	N/A
				Obstruction Type			Storm Grate/Utility Type	
					N/A			N/A
						Yes	Surface Condition? (G/P)	Good
	Total Cost:	\$ 1850.00
