Access Compliance Report

Public Rights-of-Way

(Curb Ramps)

Intersection ID: 45785	Main Street: SUGARBUSH_DR	Cross Street: LONG_HILL_DR	Location: W
ADA ID: 53A6DFDC2183	Ramp Type: PerpDiag	Initial Pass/Fail: Fail	Overall Compliance: No
		Severity Score: 25

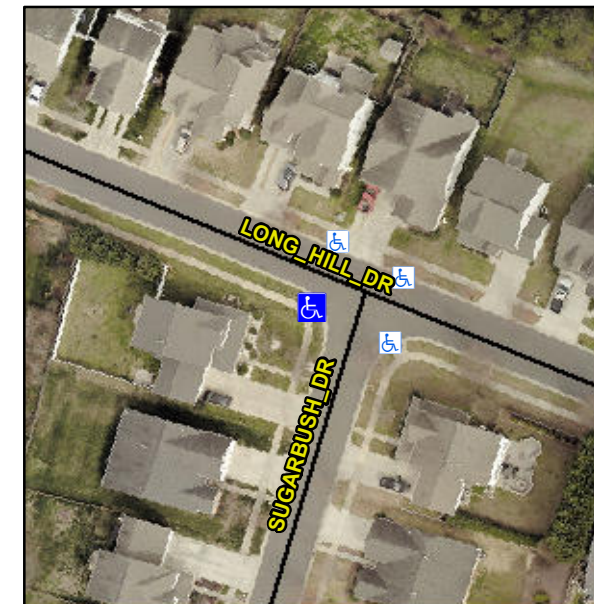
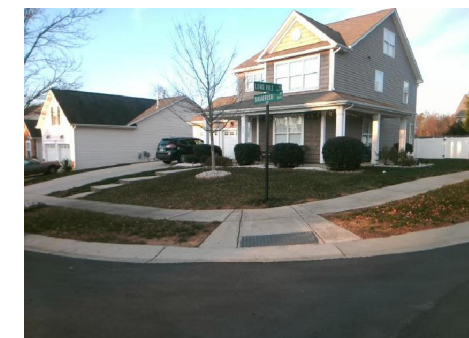
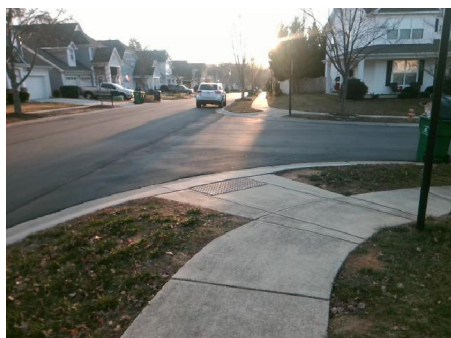
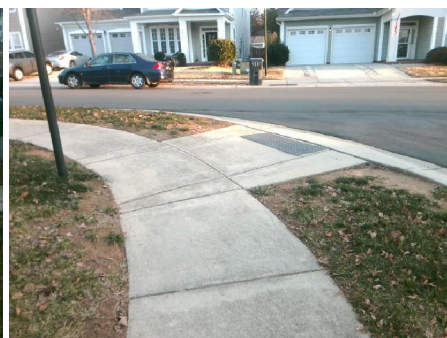
Not Found, R304.5.3

Compliance	Description	Data	Compliance	Description	Data
N/A	Ramp Length (in)	73.0	Yes	Ramp Slope (%)	6.0
Yes	Ramp Width (in)	48.0	No	Ramp XSlope (%)	8.0
N/A	Flare Type LT	N/A	N/A	Flare Type RT	N/A
N/A	Flare Slope LT (%)	N/A	N/A	Flare Slope RT (%)	N/A
N/A	Flare Traversable LT?	N/A	N/A	Flare Traversable RT?	N/A
N/A	Landing Length (in)	N/A	N/A	DWS Provided?	N/A
N/A	Landing Width (in)	N/A	N/A	DWS Contrast?	N/A
N/A	Landing Slope (%)	N/A	N/A	DWS Length (in)	N/A
N/A	Landing X Slope (%)	N/A	N/A	DWS Full Width?	N/A
N/A	Landing Curb? (Y/N)	N/A	N/A	DWS Offset (in)	N/A
N/A	Shared Landing?	N/A			
N/A	Gutter Ponding?	N/A	N/A	Gutter Slope (%)	N/A
N/A	Gutter Lip Ht (in)	N/A	N/A	Gutter X Slope (%)	N/A
N/A	Painted X Walk1?	No	N/A	Painted X Walk2?	No
	X Walk 1 Direction	To SE		X Walk 2 Direction	To NE
N/A	X Walk 1 Width (in)	N/A	N/A	X Walk 2 Width (in)	N/A
	X Walk 1 Slope (%)	2.2		X Walk 2 Slope (%)	4.6
	X Walk 1 X Slope (%)	5.5		X Walk 2 X Slope (%)	0.9

N/A	Ramp inside XWalk1?	N/A	N/A	Ramp inside XWalk2?	N/A
	Road Slope (%)	6.3	N/A	Clear Space?	N/A
	Road X Slope (%)	2.1	N/A	Clear Space to XWalk (in)	N/A
N/A	Any Obstructions?	N/A	N/A	Storm Grate/Utility Hazard?	N/A
	Obstruction Type			Storm Grate/Utility Type	
		N/A			N/A
			Yes	Surface Condition? (G/P)	Good

Remove & Replace Curb Ramp With Two New Directional Ramps or Equivalent.

Total Cost: \$ 3200.00
