# Access Compliance Report

## Public Rights-of-Way

### (Curb Ramps)

Intersection ID: 13895	Main Street: ELIZABETH_AV	Cross Street: TRAVIS_AV	Location: SE
ADA ID: 53AB9D645A75	Ramp Type: Perp	Initial Pass/Fail: Fail	Overall Compliance: No
Codes/Mitigation Info/Possible Solution		Field Measurements/Component Compliance	
Severity Score: 8.75

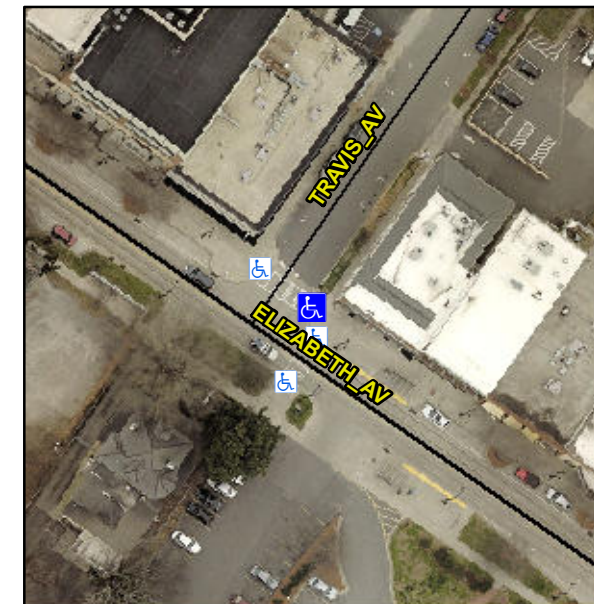
Compliance	Description	Data	Compliance	Description	Data
N/A	Ramp Length (in)	68.0	Yes	Ramp Slope (%)	6.1
No	Ramp Width (in)	47.5	Yes	Ramp XSlope (%)	0.3
N/A	Flare Type LT	N/A	N/A	Flare Type RT	N/A
N/A	Flare Slope LT (%)	N/A	N/A	Flare Slope RT (%)	N/A
N/A	Flare Traversable LT?	N/A	N/A	Flare Traversable RT?	N/A
N/A	Landing Length (in)	N/A	N/A	DWS Provided?	N/A
N/A	Landing Width (in)	N/A	N/A	DWS Contrast?	N/A
N/A	Landing Slope (%)	N/A	N/A	DWS Length (in)	N/A
N/A	Landing X Slope (%)	N/A	N/A	DWS Full Width?	N/A
N/A	Landing Curb? (Y/N)	N/A	N/A	DWS Offset (in)	N/A
N/A	Shared Landing?	N/A			
N/A	Gutter Ponding?	N/A	N/A	Gutter Slope (%)	N/A
N/A	Gutter Lip Ht (in)	N/A	N/A	Gutter X Slope (%)	N/A
N/A	Painted X Walk1?	Yes	N/A	Painted X Walk2?	N/A
	X Walk 1 Direction	To NW		X Walk 2 Direction	N/A
N/A	X Walk 1 Width (in)	110.0	N/A	X Walk 2 Width (in)	N/A
	X Walk 1 Slope (%)	3.1		X Walk 2 Slope (%)	N/A
	X Walk 1 X Slope (%)	1.4		X Walk 2 X Slope (%)	N/A

N/A	Ramp inside XWalk1?	Yes	N/A	Ramp inside XWalk2?	N/A
	Road Slope (%)	N/A	N/A	Clear Space?	N/A
	Road X Slope (%)	N/A	N/A	Clear Space to XWalk (in)	N/A
N/A	Any Obstructions?	N/A	N/A	Storm Grate/Utility Hazard?	N/A
	Obstruction Type			Storm Grate/Utility Type	
		N/A			N/A
			Yes	Surface Condition? (G/P)	Good

**Remove & Replace Entire Ramp.**
