Access Compliance Report Public Rights-of-Way (Curb Ramps)

Intersection ID: 7913 Main Street: BROOKSHIRE_BV Cross Street: N_CLOUDMAN_ST Location: N

ADA ID: 53AC135051FE Ramp Type: Para Initial Pass/Fail: Fail Overall Compliance: No Severity Score: 13.75

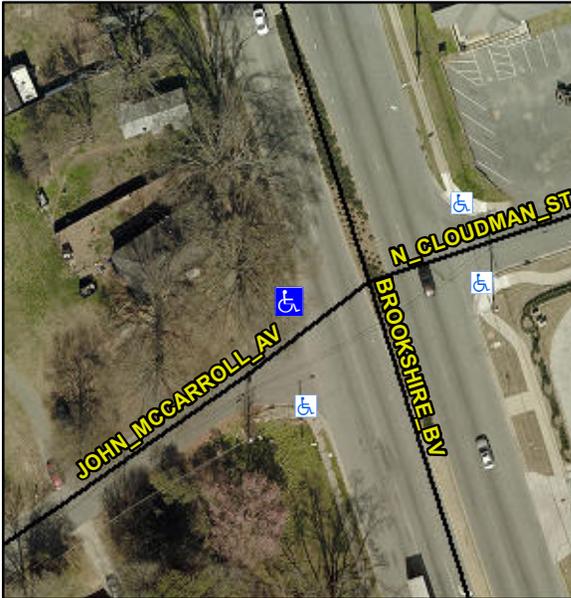
LT RP < 5%

Compliance	Description	Data	Compliance	Description	Data
N/A	Ramp Length LT (in)	54.0	N/A	Ramp Length RT (in)	45.0
Yes	Ramp Width LT (in)	84.0	Yes	Ramp Width RT (in)	84.0
Yes	Ramp Slope LT (%)	1.5	No	Ramp Slope RT (%)	10.5
Yes	Ramp XSlope LT (%)	0.2	No	Ramp XSlope RT (%)	3.3
N/A	Landing Length (in)	N/A	N/A	DWS Provided?	N/A
N/A	Landing Width (in)	N/A	N/A	DWS Contrast?	N/A
N/A	Landing Slope (%)	N/A	N/A	DWS Length (in)	N/A
N/A	Landing X Slope (%)	N/A	N/A	DWS Full Width?	N/A
N/A	Landing Curb? (Y/N)	N/A	N/A	DWS Offset (in)	N/A
N/A	Shared Landing?	N/A			
N/A	Gutter Ponding?	N/A	N/A	Gutter Slope (%)	N/A
N/A	Gutter Lip Ht (in)	N/A	N/A	Gutter X Slope (%)	N/A
N/A	Painted X Walk1?	No	N/A	Painted X Walk2?	N/A
	X Walk 1 Direction	To S		X Walk 2 Direction	N/A
N/A	X Walk 1 Width (in)	N/A	N/A	X Walk 2 Width (in)	N/A
	X Walk 1 Slope (%)	1.8		X Walk 2 Slope (%)	N/A
	X Walk 1 X Slope (%)	2.4		X Walk 2 X Slope (%)	N/A
N/A	Ramp inside XWalk1?	N/A	N/A	Ramp inside XWalk2?	N/A

Road Slope (%)	N/A	N/A	Clear Space?	N/A
	Road X Slope (%)	N/A	N/A	Clear Space to XWalk (in)	N/A
N/A	Any Obstructions?	N/A	N/A	Storm Grate/Utility Hazard?	N/A
	Obstruction Type			Storm Grate/Utility Type	
	Total Cost:	\$ 1600.00	N/A		N/A
			Yes	Surface Condition? (G/P)	Good
			N/A	Curb Slope (%)	23.3

Remove & Replace Entire Ramp.

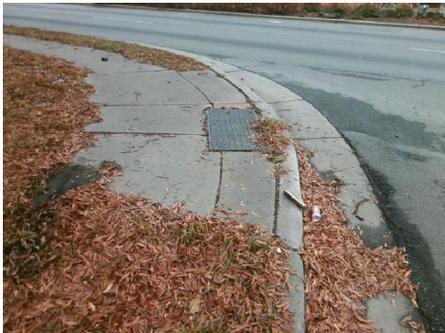
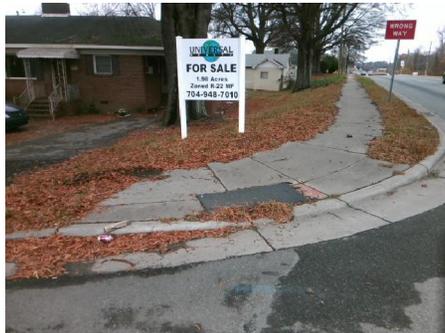
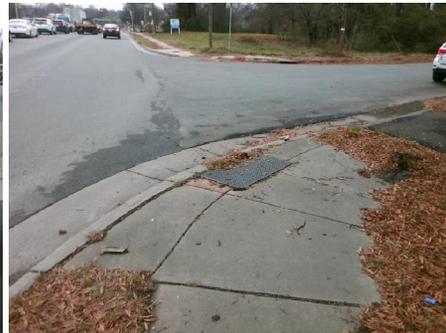
Street 1 Name **N CLOUDMAN ST**
 Stop Condition-Street 1 **StopSign**
 Street 2 Name **N/A**
 Stop Condition-Street 2 **N/A**
