Access Compliance Report

Public Rights-of-Way

(Curb Ramps)

Intersection ID: 18583	Main Street: BURTONWOOD_CR	Cross Street: MONROE_RD	Location: SW
ADA ID: 53BAC0A575F0	Ramp Type: PerpDiag	Initial Pass/Fail: Fail	Overall Compliance: No
		Severity Score: 25

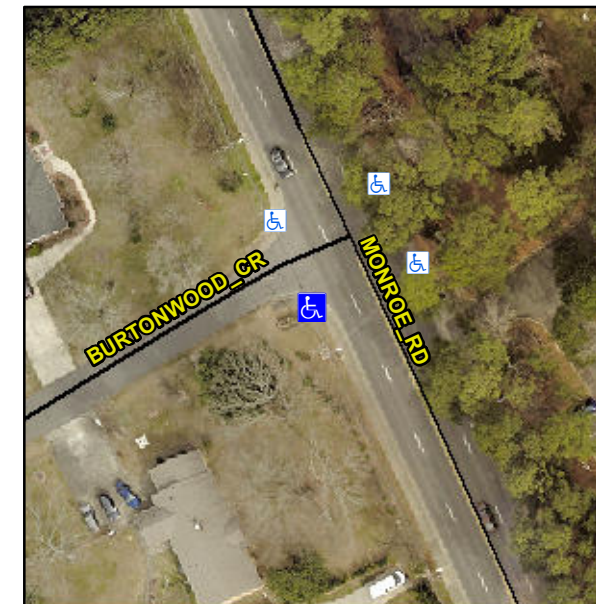
Not Found, R304.2.2, R304.5.3

Compliance	Description	Data	Compliance	Description	Data
N/A	Ramp Length (in)	57.0	No	Ramp Slope (%)	11.6
Yes	Ramp Width (in)	48.0	No	Ramp XSlope (%)	6.3
N/A	Flare Type LT	N/A	N/A	Flare Type RT	N/A
N/A	Flare Slope LT (%)	N/A	N/A	Flare Slope RT (%)	N/A
N/A	Flare Traversable LT?	N/A	N/A	Flare Traversable RT?	N/A
N/A	Landing Length (in)	N/A	N/A	DWS Provided?	N/A
N/A	Landing Width (in)	N/A	N/A	DWS Contrast?	N/A
N/A	Landing Slope (%)	N/A	N/A	DWS Length (in)	N/A
N/A	Landing X Slope (%)	N/A	N/A	DWS Full Width?	N/A
N/A	Landing Curb? (Y/N)	N/A	N/A	DWS Offset (in)	N/A
N/A	Shared Landing?	N/A			
N/A	Gutter Ponding?	N/A	N/A	Gutter Slope (%)	N/A
N/A	Gutter Lip Ht (in)	N/A	N/A	Gutter X Slope (%)	N/A
N/A	Painted X Walk1?	No	N/A	Painted X Walk2?	No
	X Walk 1 Direction	To E		X Walk 2 Direction	To N
N/A	X Walk 1 Width (in)	N/A	N/A	X Walk 2 Width (in)	N/A
	X Walk 1 Slope (%)	3.0		X Walk 2 Slope (%)	0.1
	X Walk 1 X Slope (%)	1.2		X Walk 2 X Slope (%)	3.2

N/A	Ramp inside XWalk1?	N/A	N/A	Ramp inside XWalk2?	N/A
	Road Slope (%)	0.1	N/A	Clear Space?	N/A
	Road X Slope (%)	4.2	N/A	Clear Space to XWalk (in)	N/A
N/A	Any Obstructions?	N/A	N/A	Storm Grate/Utility Hazard?	N/A
	Obstruction Type			Storm Grate/Utility Type	
		N/A			N/A
			Yes	Surface Condition? (G/P)	Good

Remove & Replace Curb Ramp With Two New Directional Ramps or Equivalent.
