Access Compliance Report Public Rights-of-Way (Curb Ramps)

Intersection ID: 10036062 Main Street: RIVERGATE PY **Cross Street: N/A** Location: NW ADA ID: 53BCCAF07F6B Ramp Type: PerpDiag Initial Pass/Fail: Fail **Overall Compliance: No Severity Score:** 12.5

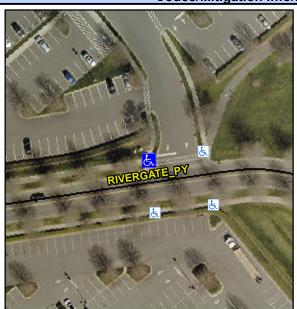
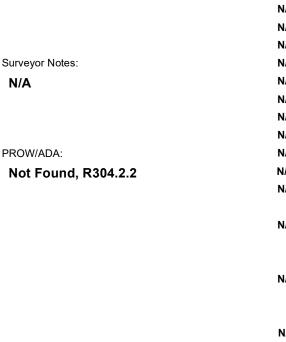
| Field Measurements/Component Compilance | | | | | | |
|---|---|---|---|---|---|---|
| | N/A | Ramp Length (in) | 48.0 | No | Ramp Slope (%) | 8.7 |
| | Yes | Ramp Width (in) | 48.0 | Yes | Ramp XSlope (%) | 0.1 |

Two New Directional Ramps or Equivalent. Surveyor Notes: N/A

Remove & Replace Curb Ramp With

Possible Solutions:

Total Cost: 3200.00
