Access Compliance Report Public Rights-of-Way (Curb Ramps)

Intersection ID: 43865 Main Street: SIDNEY_CREST_AV Cross Street: STONE_TRAIL_RD Location: S

ADA ID: 53C0399FE577 Ramp Type: Perp Initial Pass/Fail: Fail Overall Compliance: No Severity Score: 21.25

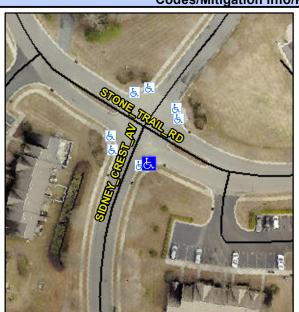
Not Found, R304.5.1, R304.2.2

Compliance Description Data Compliance Description Data No N/A Ramp Length (in) 49.5 Ramp Slope (%) 8.7 No Ramp Width (in) 39.5 Yes Ramp XSlope (%) 0.0 N/A N/A Flare Type LT N/A Flare Type RT N/A N/A N/A N/A Flare Slope RT (%) Flare Slope LT (%) N/A N/A Flare Traversable LT? N/A N/A Flare Traversable RT? N/A N/A N/A N/A DWS Provided? N/A Landing Length (in) N/A Landing Width (in) N/A N/A **DWS Contrast?** N/A N/A N/A Landing Slope (%) N/A DWS Length (in) N/A N/A Landing X Slope (%) N/A N/A DWS Full Width? N/A Landing Curb? (Y/N) N/A N/A DWS Offset (in) N/A N/A Shared Landing? **Gutter Ponding?** N/A N/A Gutter Slope (%) N/A Gutter Lip Ht (in) N/A N/A Gutter X Slope (%) N/A Painted X Walk1? No N/A Painted X Walk2? N/A X Walk 1 Direction To NE X Walk 2 Direction N/A N/A X Walk 1 Width (in) X Walk 2 Width (in) N/A X Walk 1 Slope (%) 2.9 X Walk 2 Slope (%) N/A X Walk 1 X Slope (%) 1.6 X Walk 2 X Slope (%) N/A N/A N/A Ramp inside XWalk1? Ramp inside XWalk2? N/A Road Slope (%) N/A N/A Clear Space? N/A Road X Slope (%) N/A N/A Clear Space to XWalk (in) N/A N/A Any Obstructions? N/A Storm Grate/Utility Hazard? N/A **Obstruction Type** Storm Grate/Utility Type N/A N/A Yes Surface Condition? (G/P) Good

Remove & Replace Entire Ramp.
