# Access Compliance Report

## Public Rights-of-Way

### (Curb Ramps)

Intersection ID: 26633	Main Street: WEDDINGTON_RD	Cross Street: FINCHER_MEADOWS_LN	Location: SE
ADA ID: 53CB1B8FB54E	Ramp Type: BlendTrans1	Initial Pass/Fail: Fail	Overall Compliance: No
Codes/Mitigation Info/Possible Solution			Severity Score: 10
			Field Measurements/Component Compliance

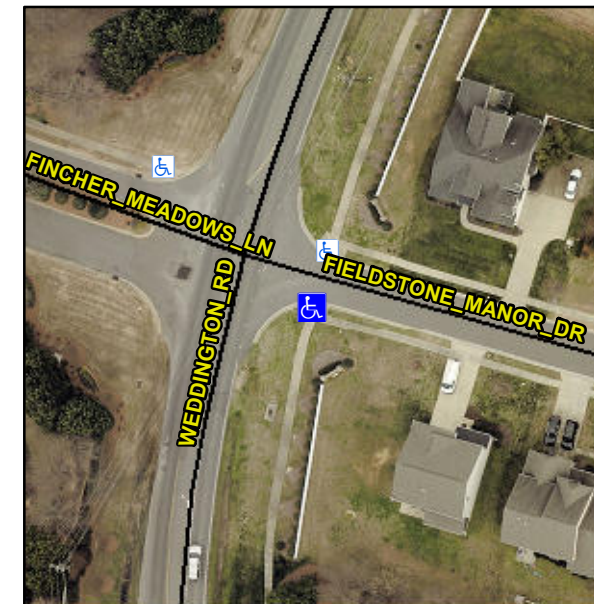
**Not Found, R304.5.1, R304.5.3**

Compliance	Description	Data	Compliance	Description	Data
N/A	Ramp Length (in)	97.0	Yes	BlendTrans Slope (%)	4.9
No	Ramp Width (in)	45.0	No	BlendTrans XSlope (%)	3.3
N/A	Flare Type LT	N/A	N/A	Flare Type RT	N/A
N/A	Flare Slope LT (%)	N/A	N/A	Flare Slope RT (%)	N/A
N/A	Flare Traversable LT?	N/A	N/A	Flare Traversable RT?	N/A
N/A	Landing Length (in)	N/A	N/A	DWS Provided?	N/A
N/A	Landing Width (in)	N/A	N/A	DWS Contrast?	N/A
N/A	Landing Slope (%)	N/A	N/A	DWS Length (in)	N/A
N/A	Landing X Slope (%)	N/A	N/A	DWS Full Width?	N/A
N/A	Landing Curb? (Y/N)	N/A	N/A	DWS Offset (in)	N/A
N/A	Shared Landing?	N/A			
N/A	Gutter Ponding?	N/A	N/A	Gutter Slope (%)	N/A
N/A	Gutter Lip Ht (in)	N/A	N/A	Gutter X Slope (%)	N/A
N/A	Painted X Walk1?	No	N/A	Painted X Walk2?	N/A
	X Walk 1 Direction	To N		X Walk 2 Direction	N/A
	X Walk 1 Width (in)	N/A		X Walk 2 Width (in)	N/A
	X Walk 1 Slope (%)	1.8		X Walk 2 Slope (%)	N/A
	X Walk 1 X Slope (%)	4.8		X Walk 2 X Slope (%)	N/A

N/A	Ramp inside XWalk1?	N/A	N/A	Ramp inside XWalk2?	N/A
	Road Slope (%)	4.8		Clear Space?	N/A
	Road X Slope (%)	1.8	N/A	Clear Space to XWalk (in)	N/A
N/A	Any Obstructions?	N/A	N/A	Storm Grate/Utility Hazard?	N/A
	Obstruction Type			Storm Grate/Utility Type	
		N/A			N/A
			Yes	Surface Condition? (G/P)	Good
			No	Curb Slope (%)	13.4

**Remove & Replace Curb Ramp With Two New Directional Ramps or Equivalent.**
