Access Compliance Report

Public Rights-of-Way

(Curb Ramps)

Intersection ID: 45180	Main Street: SOCIETY_ST	Cross Street: TORRELLE_DR	Location: SW
ADA ID: 53CC91BAF19D	Ramp Type: Perp	Initial Pass/Fail: Fail	Overall Compliance: No
Codes/Mitigation Info/Possible Solution		Field Measurements/Component Compliance	
Severity Score: 13.75

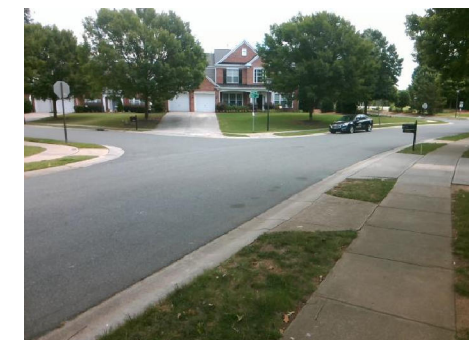
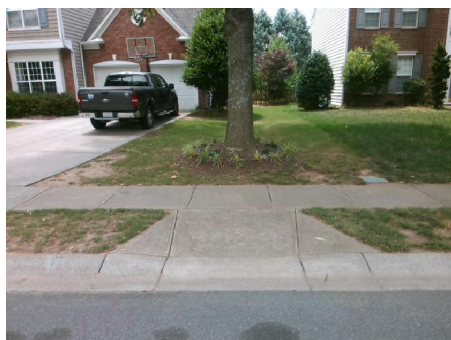
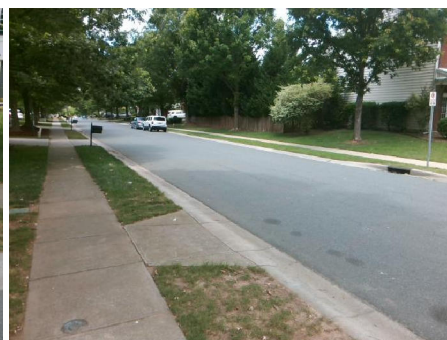
Not Found, R304.2.2, R304.5.3

Compliance	Description	Data	Compliance	Description	Data
N/A	Ramp Length (in)	48.0	No	Ramp Slope (%)	9.5
Yes	Ramp Width (in)	55.0	No	Ramp XSlope (%)	2.2
N/A	Flare Type LT	N/A	N/A	Flare Type RT	N/A
N/A	Flare Slope LT (%)	N/A	N/A	Flare Slope RT (%)	N/A
N/A	Flare Traversable LT?	N/A	N/A	Flare Traversable RT?	N/A
N/A	Landing Length (in)	N/A	N/A	DWS Provided?	N/A
N/A	Landing Width (in)	N/A	N/A	DWS Contrast?	N/A
N/A	Landing Slope (%)	N/A	N/A	DWS Length (in)	N/A
N/A	Landing X Slope (%)	N/A	N/A	DWS Full Width?	N/A
N/A	Landing Curb? (Y/N)	N/A	N/A	DWS Offset (in)	N/A
N/A	Shared Landing?	N/A			
N/A	Gutter Ponding?	N/A	N/A	Gutter Slope (%)	N/A
N/A	Gutter Lip Ht (in)	N/A	N/A	Gutter X Slope (%)	N/A
N/A	Painted X Walk1?	No	N/A	Painted X Walk2?	N/A
	X Walk 1 Direction	To NE		X Walk 2 Direction	N/A
N/A	X Walk 1 Width (in)	N/A	N/A	X Walk 2 Width (in)	N/A
	X Walk 1 Slope (%)	1.5		X Walk 2 Slope (%)	N/A
	X Walk 1 X Slope (%)	0.4		X Walk 2 X Slope (%)	N/A

N/A	Ramp inside XWalk1?	N/A	N/A	Ramp inside XWalk2?	N/A
	Road Slope (%)	N/A	N/A	Clear Space?	N/A
	Road X Slope (%)	N/A	N/A	Clear Space to XWalk (in)	N/A
N/A	Any Obstructions?	N/A	N/A	Storm Grate/Utility Hazard?	N/A
	Obstruction Type			Storm Grate/Utility Type	
		N/A			N/A
			Yes	Surface Condition? (G/P)	Good

Possible Solutions:

Remove & Replace Entire Ramp.
