Access Compliance Report

Public Rights-of-Way

(Curb Ramps)

Intersection ID: 45705	Main Street: CALDWELL RIDGE PY	Cross Street: N/A	Location: NE
ADA ID: 53CDAB074F85	Ramp Type: Perp	Initial Pass/Fail: Fail	Overall Compliance: No
		Severity Score: 10

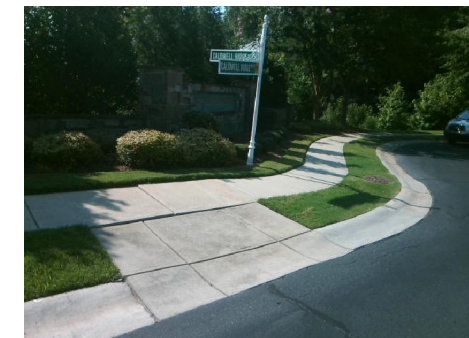
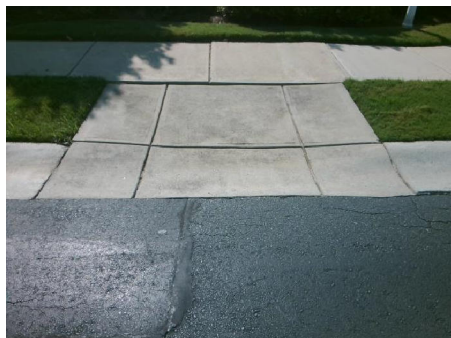
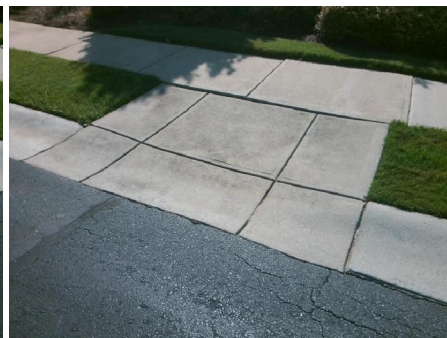
Not Found, R304.5.1

Compliance	Description	Data	Compliance	Description	Data
N/A	Ramp Length (in)	44.0	Yes	Ramp Slope (%)	6.7
No	Ramp Width (in)	46.5	Yes	Ramp XSlope (%)	3.6
N/A	Flare Type LT	N/A	N/A	Flare Type RT	N/A
N/A	Flare Slope LT (%)	N/A	N/A	Flare Slope RT (%)	N/A
N/A	Flare Traversable LT?	N/A	N/A	Flare Traversable RT?	N/A
N/A	Landing Length (in)	N/A	N/A	DWS Provided?	N/A
N/A	Landing Width (in)	N/A	N/A	DWS Contrast?	N/A
N/A	Landing Slope (%)	N/A	N/A	DWS Length (in)	N/A
N/A	Landing X Slope (%)	N/A	N/A	DWS Full Width?	N/A
N/A	Landing Curb? (Y/N)	N/A	N/A	DWS Offset (in)	N/A
N/A	Shared Landing?	N/A			
N/A	Gutter Ponding?	N/A	N/A	Gutter Slope (%)	N/A
N/A	Gutter Lip Ht (in)	N/A	N/A	Gutter X Slope (%)	N/A
N/A	Painted X Walk1?	No	N/A	Painted X Walk2?	N/A
	X Walk 1 Direction	To NW		X Walk 2 Direction	N/A
N/A	X Walk 1 Width (in)	N/A	N/A	X Walk 2 Width (in)	N/A
	X Walk 1 Slope (%)	6.8		X Walk 2 Slope (%)	N/A
	X Walk 1 X Slope (%)	3.6		X Walk 2 X Slope (%)	N/A

Remove & Replace Entire Ramp.
