# Access Compliance Report

## Public Rights-of-Way

### (Curb Ramps)

| Intersection ID: 49450 | Main Street: MARICOPA_RD | Cross Street: ALVARADO_WY | Location: SW |

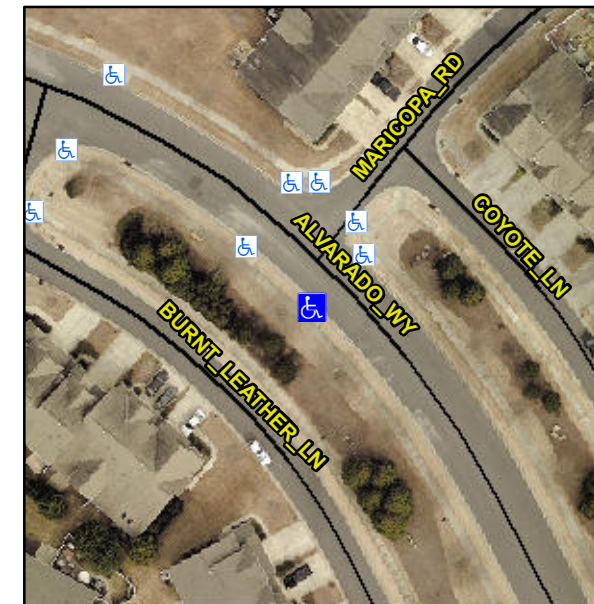
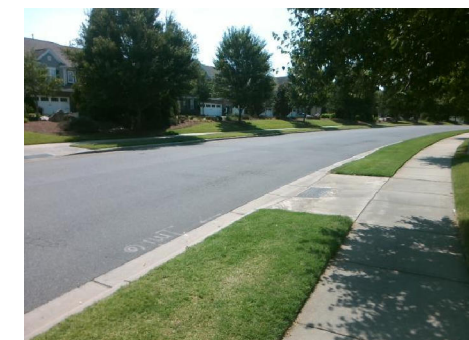
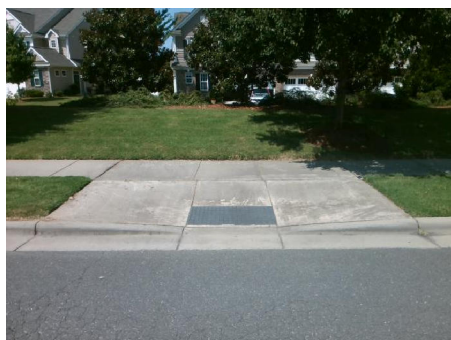
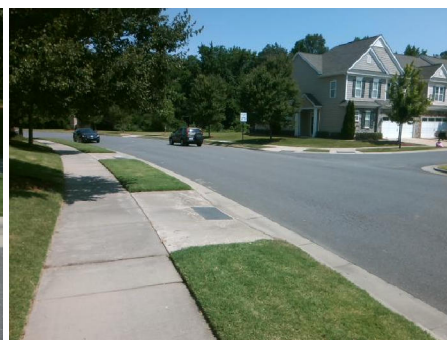
| ADA ID: 53D069DEE470 | Ramp Type: Perp | Initial Pass/Fail: Fail | Overall Compliance: No |

| Compliance | Description | Data | Compliance | Description | Data |
|---|---|---|---|---|---|
| N/A | Ramp Length (in) | 69.5 | No | Ramp Slope (%) | 10.1 |
| No | Ramp Width (in) | 37.0 | Yes | Ramp XSlope (%) | 0.8 |

**Remove & Replace Entire Ramp.**

**R304.5.1, R304.2.2**
