Access Compliance Report Public Rights-of-Way (Curb Ramps)

Intersection ID: 26107 Main Street: CARSWELL LN Cross Street: PINEVILLE-MATTHEWS_RD Location: SE ADA ID: 53D6264740B6 Ramp Type: PerpDiag Initial Pass/Fail: Fail **Overall Compliance: No Severity Score:** 22.5

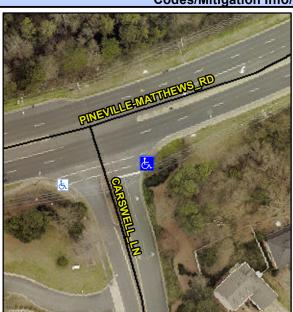
Field Measurements/Component Compliance					
Compliance Description		Data	Comp	liance Description	Data
N/A	Ramp Length (in)	61.0	No	Ramp Slope (%)	11.1
No	Ramp Width (in)	46.0	No	Ramp XSlope (%)	4.0
N/A	Flare Type LT	N/A	N/A	Flare Type RT	N/A
N/A	Flare Slope LT (%)	N/A	N/A	Flare Slope RT (%)	N/A
N/A	Flare Traversable LT?	N/A	N/A	Flare Traversable RT?	N/A
N/A	Landing Length (in)	N/A	N/A	DWS Provided?	N/A
N/A	Landing Width (in)	N/A	N/A	DWS Contrast?	N/A
N/A	Landing Slope (%)	N/A	N/A	DWS Length (in)	N/A
N/A	Landing X Slope (%)	N/A	N/A	DWS Full Width?	N/A
N/A	Landing Curb? (Y/N)	N/A	N/A	DWS Offset (in)	N/A
N/A	Shared Landing?	N/A			
N/A	Gutter Ponding?	N/A	N/A	Gutter Slope (%)	N/A
N/A	Gutter Lip Ht (in)	N/A	N/A	Gutter X Slope (%)	N/A
N/A	Painted X Walk1?	No	N/A	Painted X Walk2?	Yes
	X Walk 1 Direction	To N		X Walk 2 Direction	To W
N/A	X Walk 1 Width (in)	N/A	N/A	X Walk 2 Width (in)	98.0
	X Walk 1 Slope (%)	4.8		X Walk 2 Slope (%)	1.1

X Walk 1 X Slope (%)	1.6		X Walk 2 X Slope (%)	4.0
N/A	Ramp inside XWalk1?	N/A	N/A	Ramp inside XWalk2?	Yes
	Road Slope (%)	4.6	N/A	Clear Space?	N/A
	Road X Slope (%)	2.2	N/A	Clear Space to XWalk (in)	N/A
N/A	Any Obstructions?	N/A	N/A	Storm Grate/Utility Hazard?	N/A
	Obstruction Type			Storm Grate/Utility Type	
		N/A			N/A
			Yes	Surface Condition? (G/P)	Good
4

Possible Solutions: Remove & Replace Curb Ramp With **Two New Directional Ramps or** Equivalent. Surveyor Notes: N/A PROW/ADA: Not Found, R304.5.1, R304.2.2, R304.5.3
