Access Compliance Report

Public Rights-of-Way

(Curb Ramps)

Intersection ID: 42959	Main Street: APPLE_DOVE_CT	Cross Street: QUAIL_ST	Location: NE
ADA ID: 53DCAE867168	Ramp Type: PerpDiag	Initial Pass/Fail: Fail	Overall Compliance: No
Codes/Mitigation Info/Possible Solution		Field Measurements/Component Compliance	
Severity Score: 33.75

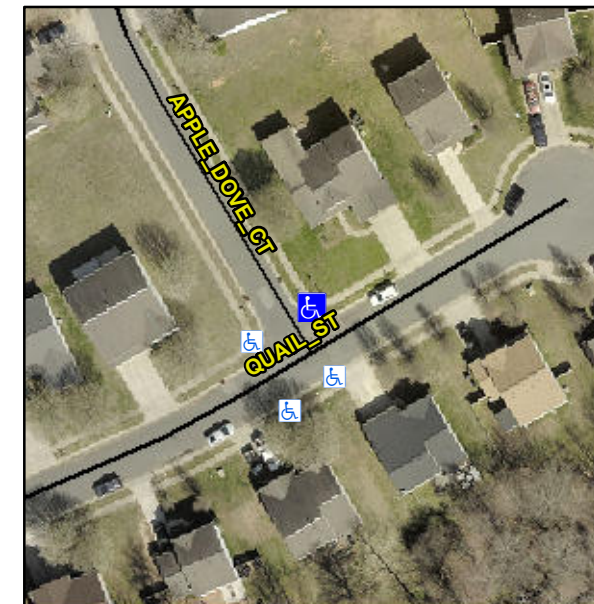
Compliance	Description	Data	Compliance	Description	Data
N/A	Ramp Length (in)	49.5	No	Ramp Slope (%)	9.6
No	Ramp Width (in)	42.0	No	Ramp XSlope (%)	6.9
N/A	Flare Type LT	N/A	N/A	Flare Type RT	N/A
N/A	Flare Slope LT (%)	N/A	N/A	Flare Slope RT (%)	N/A
N/A	Flare Traversable LT?	N/A	N/A	Flare Traversable RT?	N/A
N/A	Landing Length (in)	N/A	N/A	DWS Provided?	N/A
N/A	Landing Width (in)	N/A	N/A	DWS Contrast?	N/A
N/A	Landing Slope (%)	N/A	N/A	DWS Length (in)	N/A
N/A	Landing X Slope (%)	N/A	N/A	DWS Full Width?	N/A
N/A	Landing Curb? (Y/N)	N/A	N/A	DWS Offset (in)	N/A
N/A	Shared Landing?	N/A			
N/A	Gutter Ponding?	N/A	N/A	Gutter Slope (%)	N/A
N/A	Gutter Lip Ht (in)	N/A	N/A	Gutter X Slope (%)	N/A
N/A	Painted X Walk1?	No	N/A	Painted X Walk2?	No
	X Walk 1 Direction	To W		X Walk 2 Direction	To S
N/A	X Walk 1 Width (in)	N/A	N/A	X Walk 2 Width (in)	N/A
	X Walk 1 Slope (%)	1.7		X Walk 2 Slope (%)	0.4
	X Walk 1 X Slope (%)	3.0		X Walk 2 X Slope (%)	3.3

N/A	Ramp inside XWalk1?	N/A	N/A	Ramp inside XWalk2?	N/A
	Road Slope (%)	5.0	N/A	Clear Space?	N/A
	Road X Slope (%)	2.3	N/A	Clear Space to XWalk (in)	N/A
N/A	Any Obstructions?	N/A	N/A	Storm Grate/Utility Hazard?	N/A
	Obstruction Type			Storm Grate/Utility Type	
		N/A			N/A
			Yes	Surface Condition? (G/P)	Good

Possible Solutions:

Remove & Replace Curb Ramp With Two New Directional Ramps or Equivalent.
