Access Compliance Report

Public Rights-of-Way

(Curb Ramps)

Intersection ID: 44171	Main Street: BELLEGARDE_DR	Cross Street: REA_RD	Location: SE
ADA ID: 53E343006378	Ramp Type: Perp	Initial Pass/Fail: Fail	Overall Compliance: No
		Severity Score: 22.5

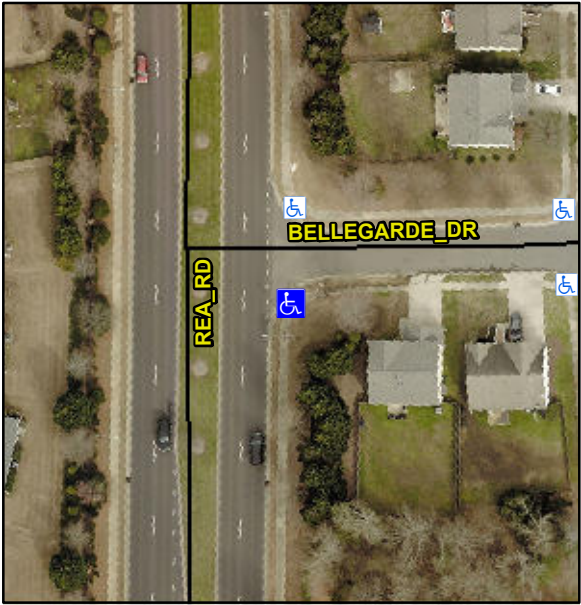
Possible Solutions:		Compliance	Description	Data
	Remove & Replace Entire Ramp.		No	Ramp Length (in)	44.0
			No	Ramp Width (in)	42.0
			N/A	Flare Type LT	N/A
			N/A	Flare Slope LT (%)	N/A
			N/A	Flare Traversable LT?	N/A
			N/A	Landing Length (in)	N/A
			N/A	Landing Width (in)	N/A
			N/A	Landing Slope (%)	N/A
			N/A	Landing X Slope (%)	N/A
			N/A	Landing Curb? (Y/N)	N/A
			N/A	Shared Landing?	N/A
			N/A	Gutter Ponding?	N/A
			N/A	Gutter Lip Ht (in)	N/A
			N/A	Painted X Walk1?	No
			N/A	X Walk 1 Direction	To N
			N/A	X Walk 1 Width (in)	N/A

0.4	X Walk 1 Slope (%)	
			0.4	X Walk 1 X Slope (%)	
			N/A	Ramp inside XWalk1?	N/A
<p>Surveyor Notes:</p> <p>N/A</p> <p>PROW/ADA:</p> <p>Not Found, R304.5.1, R304.2.2, R304.5.3</p>			N/A	Flare Type RT	N/A
			N/A	Flare Slope RT (%)	N/A
			N/A	Flare Traversable RT?	N/A
			N/A	DWS Provided?	N/A
			N/A	DWS Contrast?	N/A
			N/A	DWS Length (in)	N/A
			N/A	DWS Full Width?	N/A
			N/A	DWS Offset (in)	N/A
			N/A	Gutter Slope (%)	N/A
			N/A	Gutter X Slope (%)	N/A
			N/A	Painted X Walk2?	N/A
			N/A	X Walk 2 Direction	N/A
			N/A	X Walk 2 Width (in)	N/A
			N/A	X Walk 2 Slope (%)	N/A
			N/A	X Walk 2 X Slope (%)	N/A
			N/A	Ramp inside XWalk2?	N/A
			N/A	Clear Space?	N/A
			N/A	Clear Space to XWalk (in)	N/A
			N/A	Storm Grate/Utility Hazard?	N/A
			N/A	Storm Grate/Utility Type	N/A
			N/A	Surface Condition? (G/P)	Good
Total Cost:		\$ 1850.00
