# Access Compliance Report

## Public Rights-of-Way

| Intersection ID: 14333 | Main Street: BARRINGER_DR | Cross Street: BEECH_NUT_RD | Location: NW |
| ADA ID: 53E36B4F39CC | Ramp Type: BlendTrans2 | Initial Pass/Fail: Pass | Overall Compliance: No |

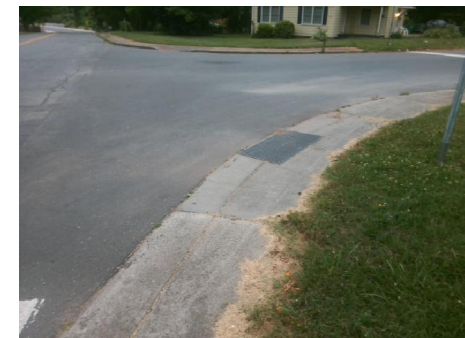
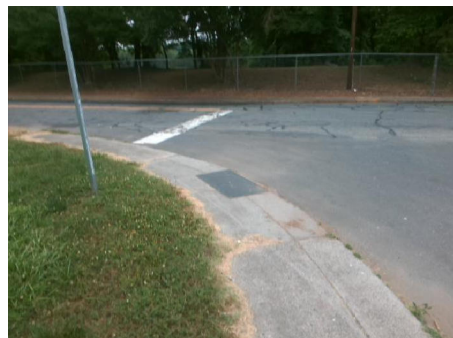
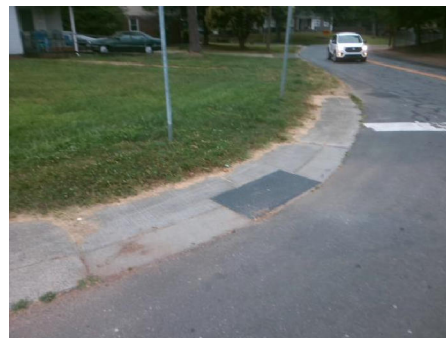
| | | Severity Score: 2.5 | |

| Compliance | Description | Data | Compliance | Description | Data |
|---|---|---|---|---|---|
| N/A | Landing X Slope (%) | N/A | No | DWS Full Width? | No |

**Remove & Replace Detectable Warning System.**

**R305.1.4**

\$ 800.00
