Access Compliance Report

Public Rights-of-Way

(Curb Ramps)

Intersection ID: 11231	Main Street: W_4TH_ST_EXT	Cross Street: WALNUT_AV	Location: SW
ADA ID: 53E7CC056F50	Ramp Type: Perp	Initial Pass/Fail: Fail	Overall Compliance: No
Severity Score: 1.25			
Codes/Mitigation Info/Possible Solution		Field Measurements/Component Compliance

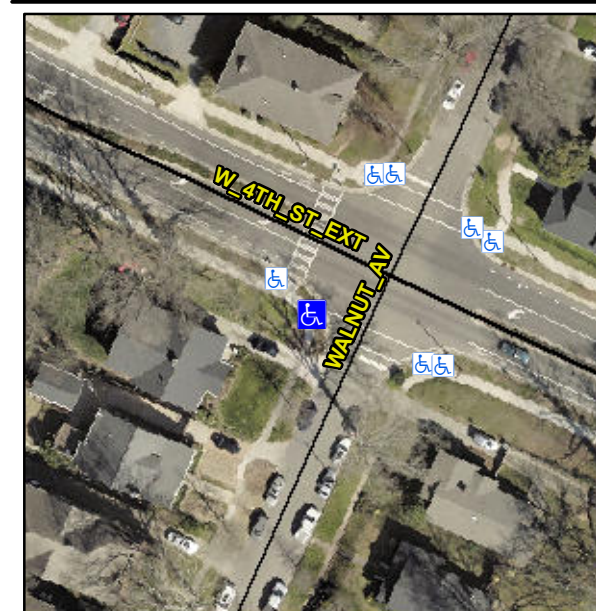
Not Found, R304.5.3

Compliance	Description	Data	Compliance	Description	Data
N/A	Ramp Length (in)	76.0	Yes	Ramp Slope (%)	7.0
Yes	Ramp Width (in)	69.0	No	Ramp XSlope (%)	2.6
N/A	Flare Type LT	N/A	N/A	Flare Type RT	N/A
N/A	Flare Slope LT (%)	N/A	N/A	Flare Slope RT (%)	N/A
N/A	Flare Traversable LT?	N/A	N/A	Flare Traversable RT?	N/A
N/A	Landing Length (in)	N/A	N/A	DWS Provided?	N/A
N/A	Landing Width (in)	N/A	N/A	DWS Contrast?	N/A
N/A	Landing Slope (%)	N/A	N/A	DWS Length (in)	N/A
N/A	Landing X Slope (%)	N/A	N/A	DWS Full Width?	N/A
N/A	Landing Curb? (Y/N)	N/A	N/A	DWS Offset (in)	N/A
N/A	Shared Landing?	N/A			
N/A	Gutter Ponding?	N/A	N/A	Gutter Slope (%)	N/A
N/A	Gutter Lip Ht (in)	N/A	N/A	Gutter X Slope (%)	N/A
N/A	Painted X Walk1?	No	N/A	Painted X Walk2?	N/A
	X Walk 1 Direction	To SE		X Walk 2 Direction	N/A
N/A	X Walk 1 Width (in)	N/A	N/A	X Walk 2 Width (in)	N/A
	X Walk 1 Slope (%)	2.1		X Walk 2 Slope (%)	N/A
	X Walk 1 X Slope (%)	2.6		X Walk 2 X Slope (%)	N/A

N/A	Ramp inside XWalk1?	N/A	N/A	Ramp inside XWalk2?	N/A
	Road Slope (%)	N/A	N/A	Clear Space?	N/A
	Road X Slope (%)	N/A	N/A	Clear Space to XWalk (in)	N/A
N/A	Any Obstructions?	N/A	N/A	Storm Grate/Utility Hazard?	N/A
	Obstruction Type			Storm Grate/Utility Type	
		N/A			N/A
		Yes		Surface Condition? (G/P)	Good

Remove & Replace Entire Ramp.
