Access Compliance Report

Public Rights-of-Way

(Curb Ramps)

Intersection ID: 14980	Main Street: DILWORTH_RD_EAST	Cross Street: EAST_BV	Location:	N
ADA ID: 53F093C5F0F3	Ramp Type: Directional1	Initial Pass/Fail: Fail	Overall Compliance: No	Severity Score: 25

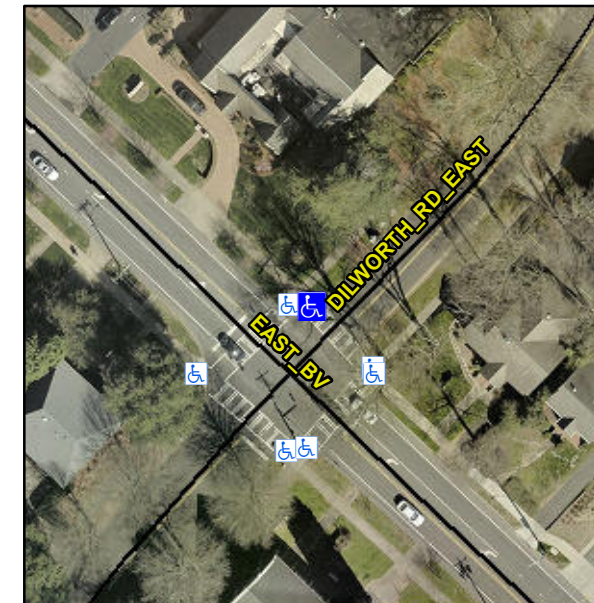
Compliance	Description	Data	Compliance	Description	Data
N/A	Ramp Length (in)	32.0	N/A	Grade Break?	N/A
Yes	Ramp Width (in)	72.0	N/A	Grade Break Slope (%)	0.0
No	Ramp Slope (%)	14.2	N/A	Grade Break XSlope (%)	0.0
Yes	Ramp XSlope (%)	0.1			
N/A	Flare Type LT	N/A	N/A	Flare Type RT	N/A
N/A	Flare Slope LT (%)	N/A	N/A	Flare Slope RT (%)	0.0
N/A	Flare Traversable LT?	N/A	N/A	Flare Traversable RT?	N/A
N/A	Landing Length (in)	0.0	N/A	DWS Provided?	N/A
N/A	Landing Width (in)	0.0	N/A	DWS Contrast?	N/A
N/A	Landing Slope (%)	0.0	N/A	DWS Length (in)	N/A
N/A	Landing X Slope (%)	0.0	N/A	DWS Full Width?	N/A
N/A	Landing Curb? (Y/N)	N/A	N/A	DWS Offset LT (in)	N/A
N/A	Shared Landing?	N/A	N/A	DWS Offset RT (in)	N/A
N/A	Gutter Ponding?	0.0	N/A	Gutter Slope (%)	N/A
N/A	Gutter Lip Ht (in)	0.0	N/A	Gutter X Slope (%)	N/A
N/A	Painted X Walk1?	Yes		Road Slope (%)	3.4
	X Walk 1 Direction	To SE		Road X Slope (%)	0.9
	X Walk 1 Width (in)	105.0		Clear Space?	N/A

X Walk 1 Slope (%)	3.4	N/A	Clear Space to XWalk (in)	N/A
	X Walk 1 X Slope (%)	0.9	N/A	Storm Grate/Utility Hazard?	N/A
N/A	Ramp inside XWalk1?	Yes		Storm Grate/Utility Type	
N/A	Any Obstructions?	N/A			N/A
	Obstruction Type		Yes	Surface Condition? (G/P)	Good
			N/A	Curb Slope (%)	1.1

Possible Solutions:

Remove & Replace Entire Ramp.

R304.2.2

\$ 1600.00
