# Access Compliance Report

## Public Rights-of-Way

### (Curb Ramps)

Intersection ID: 14338	Main Street: BARNHILL_DR	Cross Street: BRIAR_CREEK_RD	Location: S
ADA ID: 53F5F53DC28B	Ramp Type: Perp	Initial Pass/Fail: Fail	Overall Compliance: No
Severity Score: 21.25			
Codes/Mitigation Info/Possible Solution		Field Measurements/Component Compliance

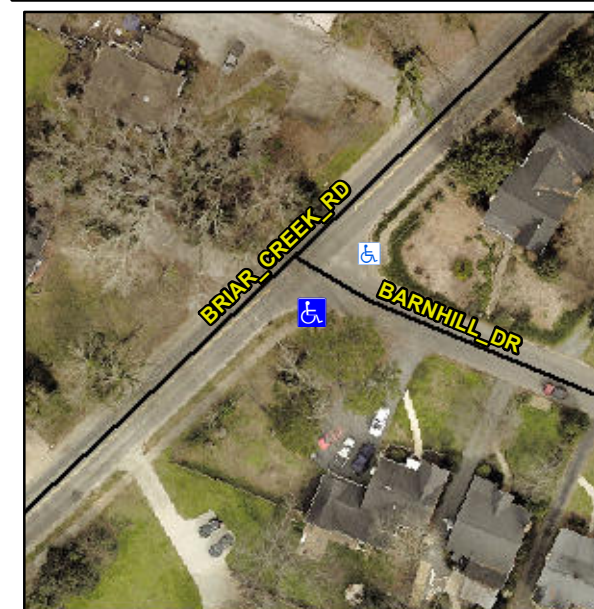
**Not Found, R304.5.1, R304.2.2**

Compliance	Description	Data	Compliance	Description	Data
N/A	Ramp Length (in)	48.0	No	Ramp Slope (%)	9.9
No	Ramp Width (in)	47.5	Yes	Ramp XSlope (%)	1.1
N/A	Flare Type LT	N/A	N/A	Flare Type RT	N/A
N/A	Flare Slope LT (%)	N/A	N/A	Flare Slope RT (%)	N/A
N/A	Flare Traversable LT?	N/A	N/A	Flare Traversable RT?	N/A
N/A	Landing Length (in)	N/A	N/A	DWS Provided?	N/A
N/A	Landing Width (in)	N/A	N/A	DWS Contrast?	N/A
N/A	Landing Slope (%)	N/A	N/A	DWS Length (in)	N/A
N/A	Landing X Slope (%)	N/A	N/A	DWS Full Width?	N/A
N/A	Landing Curb? (Y/N)	N/A	N/A	DWS Offset (in)	N/A
N/A	Shared Landing?	N/A			
N/A	Gutter Ponding?	N/A	N/A	Gutter Slope (%)	N/A
N/A	Gutter Lip Ht (in)	N/A	N/A	Gutter X Slope (%)	N/A
N/A	Painted X Walk1?	No	N/A	Painted X Walk2?	N/A
	X Walk 1 Direction	To NE		X Walk 2 Direction	N/A
N/A	X Walk 1 Width (in)	N/A	N/A	X Walk 2 Width (in)	N/A
	X Walk 1 Slope (%)	4.6		X Walk 2 Slope (%)	N/A
	X Walk 1 X Slope (%)	0.0		X Walk 2 X Slope (%)	N/A

**Remove & Replace Entire Ramp.**

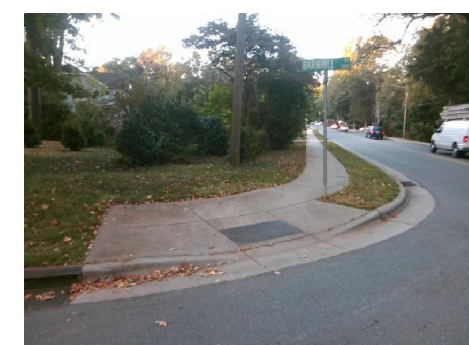
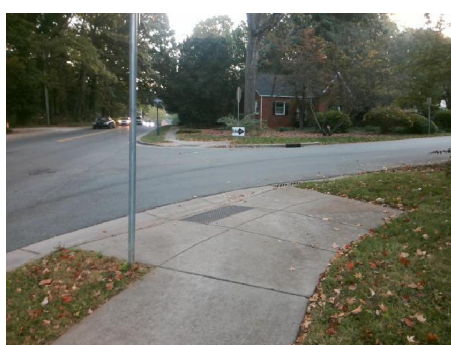
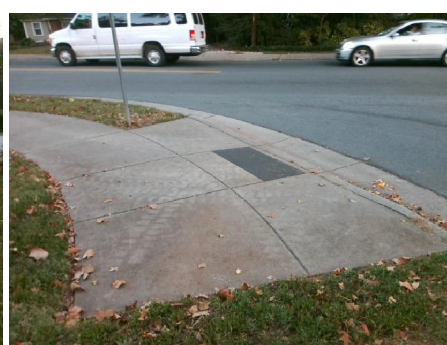
N/A	Ramp inside XWalk1?	N/A	N/A	Ramp inside XWalk2?	N/A
	Road Slope (%)	N/A	N/A	Clear Space?	N/A
	Road X Slope (%)	N/A	N/A	Clear Space to XWalk (in)	N/A
N/A	Any Obstructions?	N/A	N/A	Storm Grate/Utility Hazard?	N/A
	Obstruction Type			Storm Grate/Utility Type	
		N/A			N/A
			Yes	Surface Condition? (G/P)	Good
