# Access Compliance Report

## Public Rights-of-Way

### (Curb Ramps)

| Intersection ID: 51473 | Main Street: LILLIESLEAF_GLENN_LN | Cross Street: TAMARRON_DR | Location: SW |

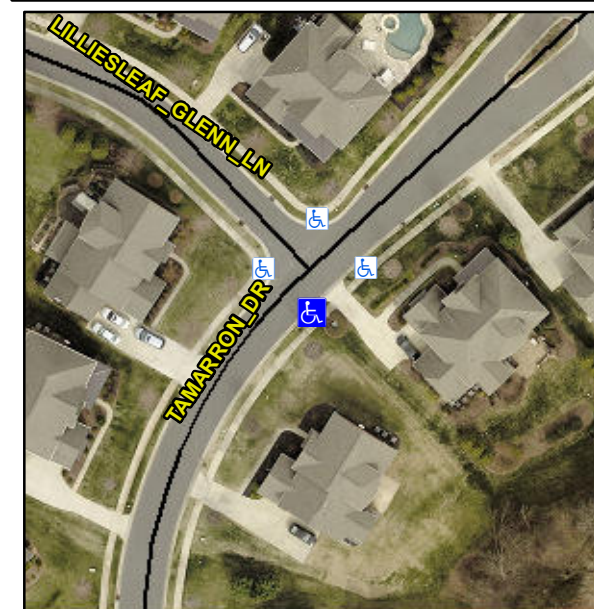
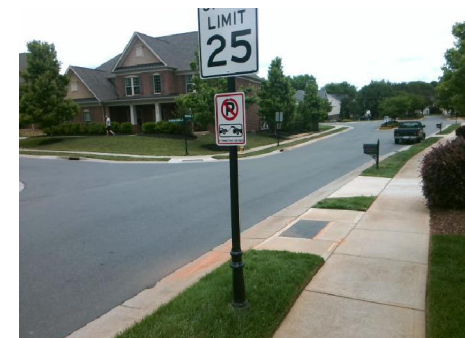
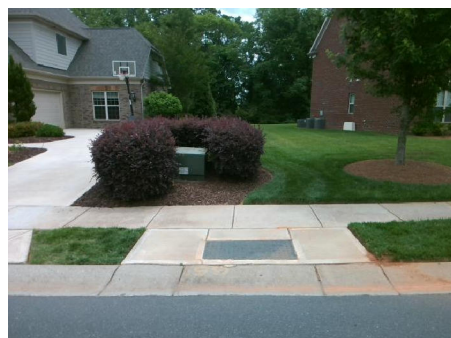
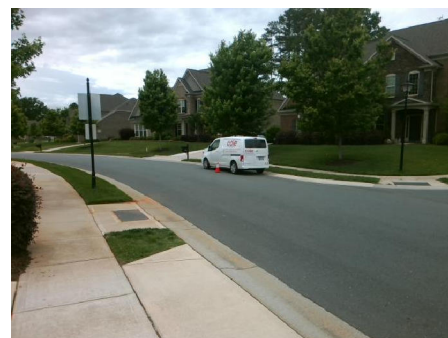
| ADA ID: 53F819AB9DF1 | Ramp Type: BlendTrans1 | Initial Pass/Fail: Pass | Overall Compliance: No |
| Severity Score: 5 | | | |

**Not Found, R304.2.2-Perp, R304.3.2-Para, R305.2, R304.5.4**

| Compliance | Description | Data | Compliance | Description | Data |
|---|---|---|---|---|---|
| No | Landing Slope (%) | 6.1 | Yes | DWS Length (in) | 24.0 |
| N/A | Landing Curb? (Y/N) | No | No | DWS Offset (in) | 4.0 |
| Yes | Gutter Ponding? | No | No | Gutter Slope (%) | 8.5 |
| | | | No | Curb Slope (%) | 14.0 |

**Remove & Replace Curb Ramp With Two New Directional Ramps or Equivalent. Remove & Replace Gutter.**
