# Access Compliance Report

## Public Rights-of-Way

### (Curb Ramps)

Intersection ID: 14659	Main Street: E_WORTHINGTON_AV	Cross Street: SPRINGDALE_AV	Location: S
ADA ID: 53FEAC62E62A	Ramp Type: Perp	Initial Pass/Fail: Fail	Overall Compliance: No
Severity Score: 13.75			
Codes/Mitigation Info/Possible Solution		Field Measurements/Component Compliance

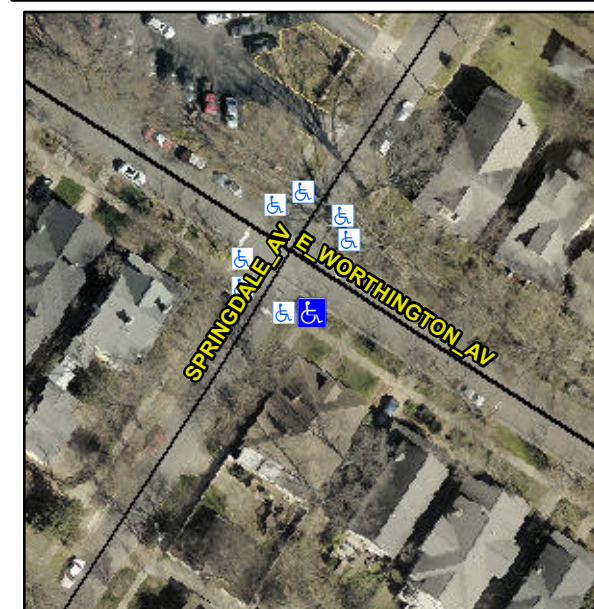
**Not Found, R304.2.2, R304.5.3**

Compliance	Description	Data	Compliance	Description	Data
N/A	Ramp Length (in)	58.0	No	Ramp Slope (%)	9.9
Yes	Ramp Width (in)	59.0	No	Ramp XSlope (%)	2.4
N/A	Flare Type LT	N/A	N/A	Flare Type RT	N/A
N/A	Flare Slope LT (%)	N/A	N/A	Flare Slope RT (%)	N/A
N/A	Flare Traversable LT?	N/A	N/A	Flare Traversable RT?	N/A
N/A	Landing Length (in)	N/A	N/A	DWS Provided?	N/A
N/A	Landing Width (in)	N/A	N/A	DWS Contrast?	N/A
N/A	Landing Slope (%)	N/A	N/A	DWS Length (in)	N/A
N/A	Landing X Slope (%)	N/A	N/A	DWS Full Width?	N/A
N/A	Landing Curb? (Y/N)	N/A	N/A	DWS Offset (in)	N/A
N/A	Shared Landing?	N/A			
N/A	Gutter Ponding?	N/A	N/A	Gutter Slope (%)	N/A
N/A	Gutter Lip Ht (in)	N/A	N/A	Gutter X Slope (%)	N/A
N/A	Painted X Walk1?	No	N/A	Painted X Walk2?	N/A
	X Walk 1 Direction	To NE		X Walk 2 Direction	N/A
N/A	X Walk 1 Width (in)	N/A	N/A	X Walk 2 Width (in)	N/A
	X Walk 1 Slope (%)	5.6		X Walk 2 Slope (%)	N/A
	X Walk 1 X Slope (%)	1.0		X Walk 2 X Slope (%)	N/A

N/A	Ramp inside XWalk1?	N/A	N/A	Ramp inside XWalk2?	N/A
	Road Slope (%)	N/A	N/A	Clear Space?	N/A
	Road X Slope (%)	N/A	N/A	Clear Space to XWalk (in)	N/A
N/A	Any Obstructions?	N/A	N/A	Storm Grate/Utility Hazard?	N/A
	Obstruction Type			Storm Grate/Utility Type	
		N/A			N/A
			Yes	Surface Condition? (G/P)	Good

**Remove & Replace Entire Ramp.**

Total Cost: \$ 1850.00
