Access Compliance Report

Public Rights-of-Way

(Curb Ramps)

Intersection ID: 12013	Main Street: FREEDOM_DR	Cross Street: W_MOREHEAD_ST	Location:	E
ADA ID: 540AFF9A5890	Ramp Type: Perp	Initial Pass/Fail: Fail	Overall Compliance: No	Severity Score: 12.5
Codes/Mitigation Info/Possible Solution		Field Measurements/Component Compliance

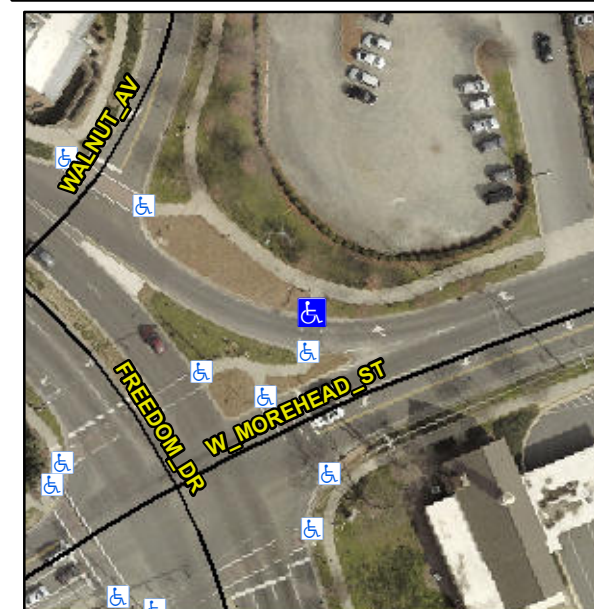
Not Found, R304.2.2

Compliance	Description	Data	Compliance	Description	Data
N/A	Ramp Length (in)	62.5	No	Ramp Slope (%)	10.3
Yes	Ramp Width (in)	48.0	Yes	Ramp XSlope (%)	0.8
N/A	Flare Type LT	N/A	N/A	Flare Type RT	N/A
N/A	Flare Slope LT (%)	N/A	N/A	Flare Slope RT (%)	N/A
N/A	Flare Traversable LT?	N/A	N/A	Flare Traversable RT?	N/A
N/A	Landing Length (in)	N/A	N/A	DWS Provided?	N/A
N/A	Landing Width (in)	N/A	N/A	DWS Contrast?	N/A
N/A	Landing Slope (%)	N/A	N/A	DWS Length (in)	N/A
N/A	Landing X Slope (%)	N/A	N/A	DWS Full Width?	N/A
N/A	Landing Curb? (Y/N)	N/A	N/A	DWS Offset (in)	N/A
N/A	Shared Landing?	N/A			
N/A	Gutter Ponding?	N/A	N/A	Gutter Slope (%)	N/A
N/A	Gutter Lip Ht (in)	N/A	N/A	Gutter X Slope (%)	N/A
N/A	Painted X Walk1?	Yes	N/A	Painted X Walk2?	N/A
	X Walk 1 Direction	To S		X Walk 2 Direction	N/A
N/A	X Walk 1 Width (in)	110.0	N/A	X Walk 2 Width (in)	N/A
	X Walk 1 Slope (%)	1.8		X Walk 2 Slope (%)	N/A
	X Walk 1 X Slope (%)	0.8		X Walk 2 X Slope (%)	N/A

N/A	Ramp inside XWalk1?	Yes	N/A	Ramp inside XWalk2?	N/A
	Road Slope (%)	N/A	N/A	Clear Space?	N/A
	Road X Slope (%)	N/A	N/A	Clear Space to XWalk (in)	N/A
N/A	Any Obstructions?	N/A	N/A	Storm Grate/Utility Hazard?	N/A
	Obstruction Type			Storm Grate/Utility Type	
		N/A			N/A
			Yes	Surface Condition? (G/P)	Good

Possible Solutions:

Remove & Replace Entire Ramp.
