# Access Compliance Report

## Public Rights-of-Way

### (Curb Ramps)

| Intersection ID: 50467 | Main Street: ARSENAL_CT | Cross Street: LENOX_POINTE_DR | Location: SW |

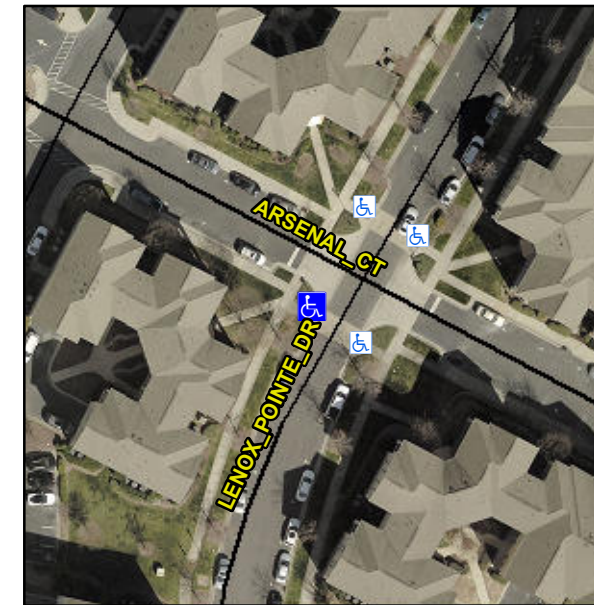
**XWALK PAVERS, NO PAINT**

**Not Found, R304.2.2-Perp, R304.3.2-Para, R305.2**

| Compliance | Description | Data | Compliance | Description | Data |
|---|---|---|---|---|---|
| No | Landing Slope (%) | 2.2 | Yes | DWS Length (in) | 24.0 |
| N/A | Landing Curb? (Y/N) | No | No | DWS Offset (in) | 5.0 |
| | | | No | Curb Slope (%) | 14.3 |

**Remove & Replace Curb Ramp With Two New Directional Ramps or Equivalent.**

Total Cost: \$ 3200.00
