Access Compliance Report

Public Rights-of-Way

(Curb Ramps)

Intersection ID: 52582	Main Street: NOBLES_AV	Cross Street: N/A	Location: NW
ADA ID: 540E06B96F24	Ramp Type: Perp	Initial Pass/Fail: Fail	Overall Compliance: No
Codes/Mitigation Info/Possible Solution		Field Measurements/Component Compliance	
Severity Score: 13.75

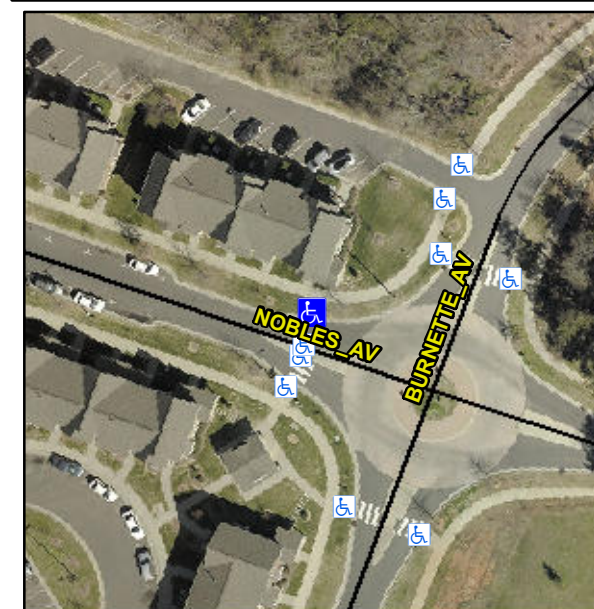
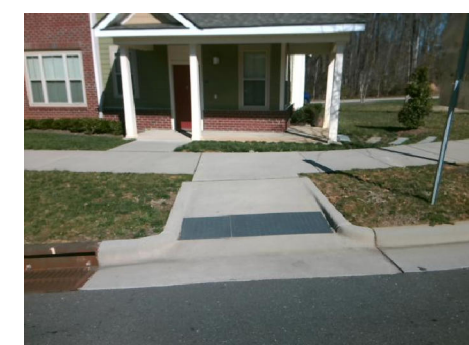
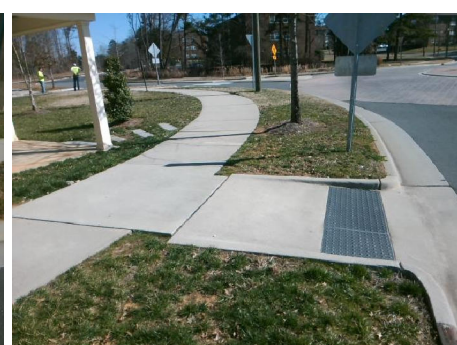
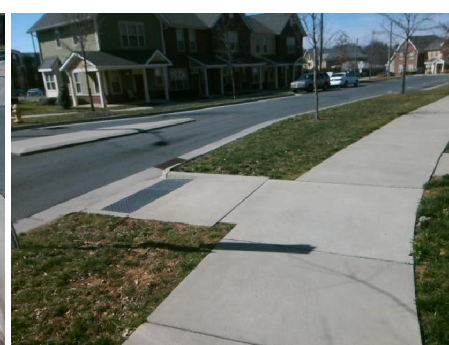
Not Found, R304.2.2, R304.5.3

Compliance	Description	Data	Compliance	Description	Data
N/A	Ramp Length (in)	80.0	No	Ramp Slope (%)	8.5
Yes	Ramp Width (in)	71.0	No	Ramp XSlope (%)	2.7
N/A	Flare Type LT	N/A	N/A	Flare Type RT	N/A
N/A	Flare Slope LT (%)	N/A	N/A	Flare Slope RT (%)	N/A
N/A	Flare Traversable LT?	N/A	N/A	Flare Traversable RT?	N/A
N/A	Landing Length (in)	N/A	N/A	DWS Provided?	N/A
N/A	Landing Width (in)	N/A	N/A	DWS Contrast?	N/A
N/A	Landing Slope (%)	N/A	N/A	DWS Length (in)	N/A
N/A	Landing X Slope (%)	N/A	N/A	DWS Full Width?	N/A
N/A	Landing Curb? (Y/N)	N/A	N/A	DWS Offset (in)	N/A
N/A	Shared Landing?	N/A			
N/A	Gutter Ponding?	N/A	N/A	Gutter Slope (%)	N/A
N/A	Gutter Lip Ht (in)	N/A	N/A	Gutter X Slope (%)	N/A
N/A	Painted X Walk1?	No	N/A	Painted X Walk2?	N/A
	X Walk 1 Direction	To S		X Walk 2 Direction	N/A
N/A	X Walk 1 Width (in)	N/A	N/A	X Walk 2 Width (in)	N/A
	X Walk 1 Slope (%)	3.5		X Walk 2 Slope (%)	N/A
	X Walk 1 X Slope (%)	3.4		X Walk 2 X Slope (%)	N/A

N/A	Ramp inside XWalk1?	N/A	N/A	Ramp inside XWalk2?	N/A
	Road Slope (%)	N/A	N/A	Clear Space?	N/A
	Road X Slope (%)	N/A	N/A	Clear Space to XWalk (in)	N/A
N/A	Any Obstructions?	N/A	N/A	Storm Grate/Utility Hazard?	N/A
	Obstruction Type			Storm Grate/Utility Type	
		N/A			N/A
			Yes	Surface Condition? (G/P)	Good

Possible Solutions:

Remove & Replace Entire Ramp.
