Access Compliance Report

Public Rights-of-Way

(Curb Ramps)

Intersection ID: 52288	Main Street: STEELE_CREEK_RD	Cross Street: DIXIE_RIVER_RD	Location: S
ADA ID: 540F2E246F90	Ramp Type: Perp	Initial Pass/Fail: Fail	Overall Compliance: No
Severity Score: 22.5			
Codes/Mitigation Info/Possible Solution		Field Measurements/Component Compliance

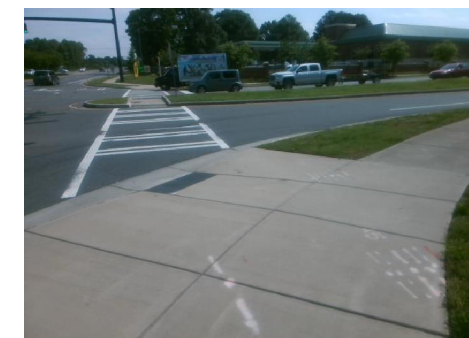
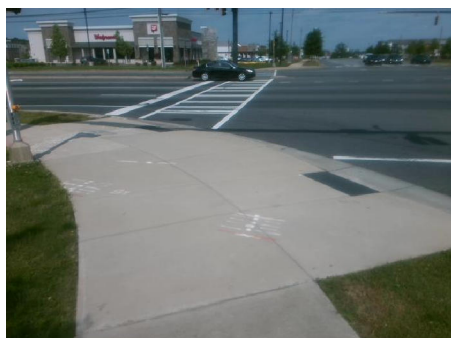
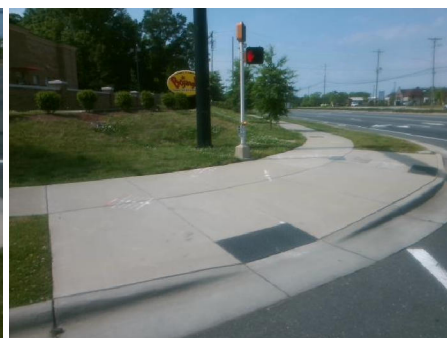
R304.5.1, R304.2.2, R304.5.3

Compliance	Description	Data	Compliance	Description	Data
N/A	Ramp Length (in)	96.0	No	Ramp Slope (%)	8.4
No	Ramp Width (in)	47.0	No	Ramp XSlope (%)	3.6
N/A	Flare Type LT	N/A	N/A	Flare Type RT	N/A
N/A	Flare Slope LT (%)	N/A	N/A	Flare Slope RT (%)	N/A
N/A	Flare Traversable LT?	N/A	N/A	Flare Traversable RT?	N/A
N/A	Landing Length (in)	N/A	N/A	DWS Provided?	N/A
N/A	Landing Width (in)	N/A	N/A	DWS Contrast?	N/A
N/A	Landing Slope (%)	N/A	N/A	DWS Length (in)	N/A
N/A	Landing X Slope (%)	N/A	N/A	DWS Full Width?	N/A
N/A	Landing Curb? (Y/N)	N/A	N/A	DWS Offset (in)	N/A
N/A	Shared Landing?	N/A			
N/A	Gutter Ponding?	N/A	N/A	Gutter Slope (%)	N/A
N/A	Gutter Lip Ht (in)	N/A	N/A	Gutter X Slope (%)	N/A
N/A	Painted X Walk1?	Yes	N/A	Painted X Walk2?	N/A
	X Walk 1 Direction	To NE		X Walk 2 Direction	N/A
N/A	X Walk 1 Width (in)	112.0	N/A	X Walk 2 Width (in)	N/A
	X Walk 1 Slope (%)	1.8		X Walk 2 Slope (%)	N/A
	X Walk 1 X Slope (%)	0.1		X Walk 2 X Slope (%)	N/A

N/A	Ramp inside XWalk1?	Yes	N/A	Ramp inside XWalk2?	N/A
	Road Slope (%)	N/A	N/A	Clear Space?	N/A
	Road X Slope (%)	N/A	N/A	Clear Space to XWalk (in)	N/A
N/A	Any Obstructions?	N/A	N/A	Storm Grate/Utility Hazard?	N/A
	Obstruction Type			Storm Grate/Utility Type	
		N/A			N/A
		Yes		Surface Condition? (G/P)	Good

Remove & Replace Entire Ramp.
