Access Compliance Report

Public Rights-of-Way

(Curb Ramps)

Intersection ID: 10689	Main Street: MILTON_RD	Cross Street: TIPPERARY_PL	Location: W
ADA ID: 54116715967B	Ramp Type: PerpDiag	Initial Pass/Fail: Fail	Overall Compliance: No
Codes/Mitigation Info/Possible Solution			Severity Score: 10
			Field Measurements/Component Compliance

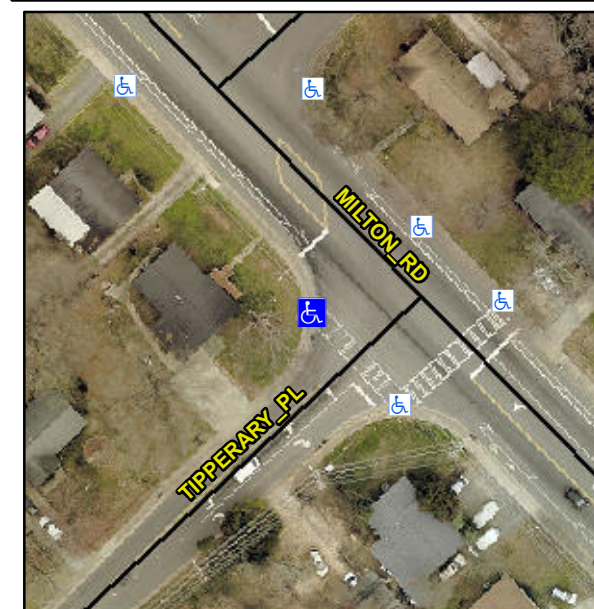
Not Found, R304.5.1, R304.5.3

Compliance	Description	Data	Compliance	Description	Data
N/A	Ramp Length (in)	60.0	Yes	Ramp Slope (%)	8.3
No	Ramp Width (in)	36.5	No	Ramp XSlope (%)	4.5
N/A	Flare Type LT	N/A	N/A	Flare Type RT	N/A
N/A	Flare Slope LT (%)	N/A	N/A	Flare Slope RT (%)	N/A
N/A	Flare Traversable LT?	N/A	N/A	Flare Traversable RT?	N/A
N/A	Landing Length (in)	N/A	N/A	DWS Provided?	N/A
N/A	Landing Width (in)	N/A	N/A	DWS Contrast?	N/A
N/A	Landing Slope (%)	N/A	N/A	DWS Length (in)	N/A
N/A	Landing X Slope (%)	N/A	N/A	DWS Full Width?	N/A
N/A	Landing Curb? (Y/N)	N/A	N/A	DWS Offset (in)	N/A
N/A	Shared Landing?	N/A			
N/A	Gutter Ponding?	N/A	N/A	Gutter Slope (%)	N/A
N/A	Gutter Lip Ht (in)	N/A	N/A	Gutter X Slope (%)	N/A
N/A	Painted X Walk1?	Yes	N/A	Painted X Walk2?	No
	X Walk 1 Direction	To SE		X Walk 2 Direction	To NE
N/A	X Walk 1 Width (in)	111.0	N/A	X Walk 2 Width (in)	N/A
	X Walk 1 Slope (%)	4.1		X Walk 2 Slope (%)	1.2
	X Walk 1 X Slope (%)	2.0		X Walk 2 X Slope (%)	4.1

N/A	Ramp inside XWalk1?	Yes	N/A	Ramp inside XWalk2?	N/A
	Road Slope (%)	4.2	N/A	Clear Space?	N/A
	Road X Slope (%)	2.7	N/A	Clear Space to XWalk (in)	N/A
N/A	Any Obstructions?	N/A	N/A	Storm Grate/Utility Hazard?	N/A
	Obstruction Type			Storm Grate/Utility Type	
		N/A			N/A
			Yes	Surface Condition? (G/P)	Good

Possible Solutions:

Remove & Replace Curb Ramp With Two New Directional Ramps or Equivalent.
