# Access Compliance Report

## Public Rights-of-Way

### (Curb Ramps)

| Intersection ID: 48453 | Main Street: ALVARADO_WY | Cross Street: RED_RUST_LN | Location: SW |

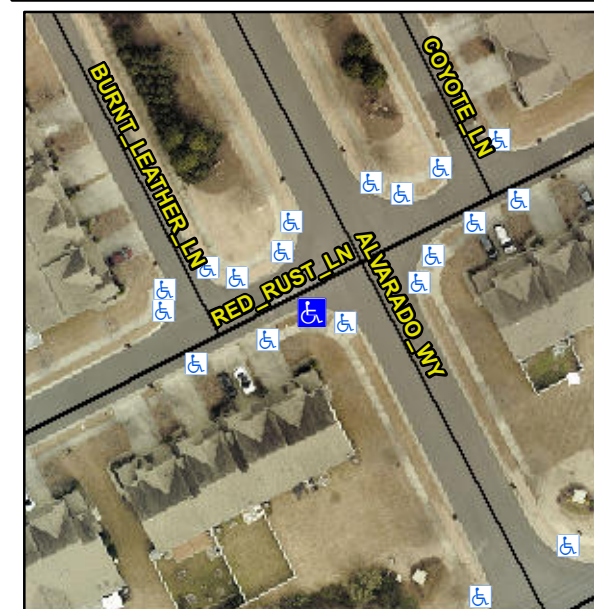
| ADA ID: 5413C645436B | Ramp Type: Perp | Initial Pass/Fail: Fail | Overall Compliance: No |
| Severity Score: 21.25 | | | |

**R304.5.1, R304.2.2**

| Compliance | Description | Data | Compliance | Description | Data |
|---|---|---|---|---|---|
| N/A | Ramp Length (in) | 77.0 | No | Ramp Slope (%) | 10.7 |
| No | Ramp Width (in) | 47.0 | Yes | Ramp XSlope (%) | 1.1 |

**Remove & Replace Entire Ramp.**

Total Cost: \$ 1850.00
