Access Compliance Report

Public Rights-of-Way

(Curb Ramps)

Intersection ID: 10906	Main Street: W_TRADE_ST	Cross Street: MONTGOMERY_ST	Location: N
ADA ID: 5418B0F6A538	Ramp Type: PerpDiag	Initial Pass/Fail: Fail	Overall Compliance: No
Severity Score: 21.25			
Codes/Mitigation Info/Possible Solution		Field Measurements/Component Compliance

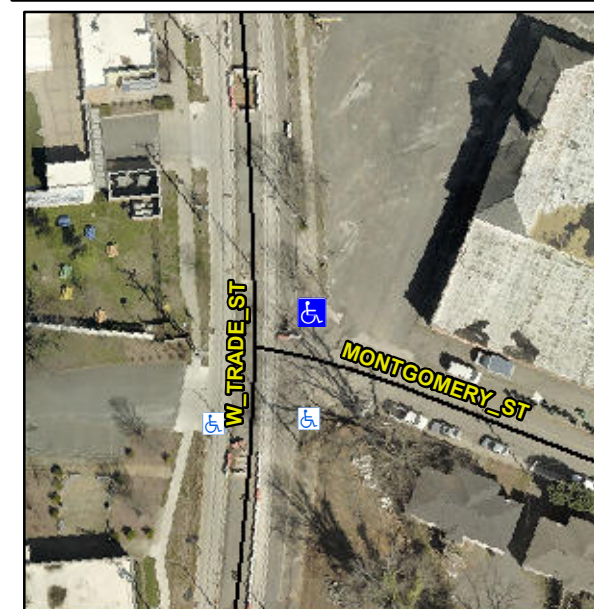
R304.5.1, R304.2.2

Compliance	Description	Data	Compliance	Description	Data
N/A	Ramp Length (in)	67.0	No	Ramp Slope (%)	9.7
No	Ramp Width (in)	45.0	Yes	Ramp XSlope (%)	0.6
N/A	Flare Type LT	N/A	N/A	Flare Type RT	N/A
N/A	Flare Slope LT (%)	N/A	N/A	Flare Slope RT (%)	N/A
N/A	Flare Traversable LT?	N/A	N/A	Flare Traversable RT?	N/A
N/A	Landing Length (in)	N/A	N/A	DWS Provided?	N/A
N/A	Landing Width (in)	N/A	N/A	DWS Contrast?	N/A
N/A	Landing Slope (%)	N/A	N/A	DWS Length (in)	N/A
N/A	Landing X Slope (%)	N/A	N/A	DWS Full Width?	N/A
N/A	Landing Curb? (Y/N)	N/A	N/A	DWS Offset (in)	N/A
N/A	Shared Landing?	N/A			
N/A	Gutter Ponding?	N/A	N/A	Gutter Slope (%)	N/A
N/A	Gutter Lip Ht (in)	0.5	N/A	Gutter X Slope (%)	N/A
N/A	Painted X Walk1?	No	N/A	Painted X Walk2?	No
	X Walk 1 Direction	To S		X Walk 2 Direction	To E
N/A	X Walk 1 Width (in)	N/A	N/A	X Walk 2 Width (in)	N/A
	X Walk 1 Slope (%)	2.1		X Walk 2 Slope (%)	3.7
	X Walk 1 X Slope (%)	2.0		X Walk 2 X Slope (%)	0.9

N/A	Ramp inside XWalk1?	N/A	N/A	Ramp inside XWalk2?	N/A
	Road Slope (%)	0.0	N/A	Clear Space?	N/A
	Road X Slope (%)	4.3	N/A	Clear Space to XWalk (in)	N/A
N/A	Any Obstructions?	N/A	N/A	Storm Grate/Utility Hazard?	N/A
	Obstruction Type			Storm Grate/Utility Type	
		N/A			N/A
			Yes	Surface Condition? (G/P)	Good

Possible Solutions:

Remove & Replace Curb Ramp With Two New Directional Ramps or Equivalent.
