Access Compliance Report

Public Rights-of-Way

(Curb Ramps)

Intersection ID: 22536	Main Street: PROVIDENCE_RD	Cross Street: SUMMER_TREE_LN	Location: SE
ADA ID: 541D574E3745	Ramp Type: Perp	Initial Pass/Fail: Fail	Overall Compliance: No
Severity Score: 46.25			
Codes/Mitigation Info/Possible Solution		Field Measurements/Component Compliance

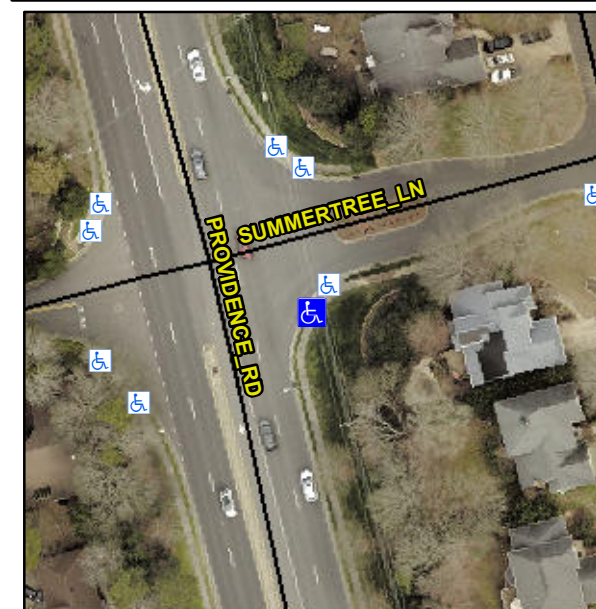
Compliance	Description	Data	Compliance	Description	Data
N/A	Ramp Length (in)	62.0	No	Ramp Slope (%)	10.2
No	Ramp Width (in)	46.0	No	Ramp XSlope (%)	7.4
N/A	Flare Type LT	N/A	N/A	Flare Type RT	N/A
N/A	Flare Slope LT (%)	N/A	N/A	Flare Slope RT (%)	N/A
N/A	Flare Traversable LT?	N/A	N/A	Flare Traversable RT?	N/A
N/A	Landing Length (in)	N/A	N/A	DWS Provided?	N/A
N/A	Landing Width (in)	N/A	N/A	DWS Contrast?	N/A
N/A	Landing Slope (%)	N/A	N/A	DWS Length (in)	N/A
N/A	Landing X Slope (%)	N/A	N/A	DWS Full Width?	N/A
N/A	Landing Curb? (Y/N)	N/A	N/A	DWS Offset (in)	N/A
N/A	Shared Landing?	N/A			
N/A	Gutter Ponding?	N/A	N/A	Gutter Slope (%)	N/A
N/A	Gutter Lip Ht (in)	N/A	N/A	Gutter X Slope (%)	N/A
N/A	Painted X Walk1?	No	N/A	Painted X Walk2?	N/A
	X Walk 1 Direction	To W		X Walk 2 Direction	N/A
N/A	X Walk 1 Width (in)	N/A	N/A	X Walk 2 Width (in)	N/A
	X Walk 1 Slope (%)	3.8		X Walk 2 Slope (%)	N/A
	X Walk 1 X Slope (%)	2.5		X Walk 2 X Slope (%)	N/A

Remove & Replace Entire Ramp.

R304.5.1, R304.2.2, R304.5.3
