Access Compliance Report

Public Rights-of-Way

(Curb Ramps)

Intersection ID: 9879	Main Street: PATTON_AV	Cross Street: CREEK_ST	Location: S
ADA ID: 5426452A8B9A	Ramp Type: Directional1	Initial Pass/Fail: Pass	Overall Compliance: No
		Severity Score: 2.5

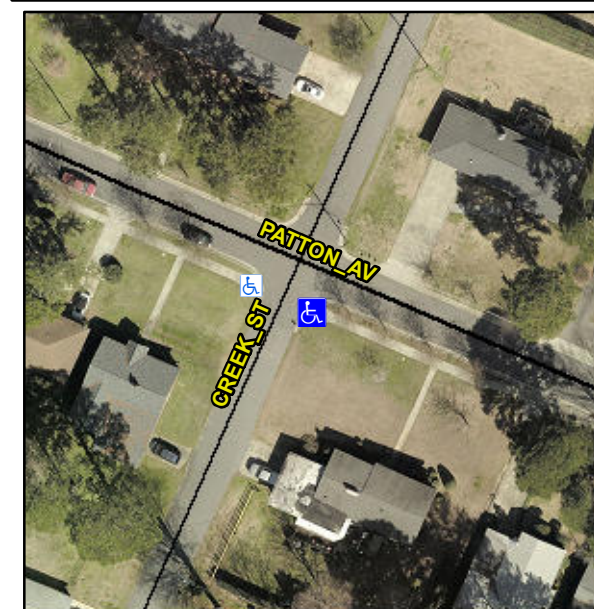
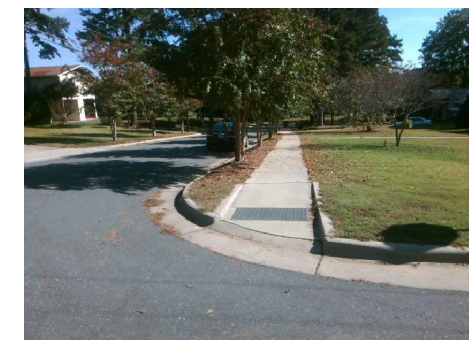
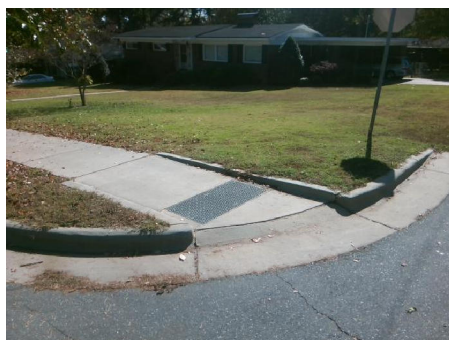
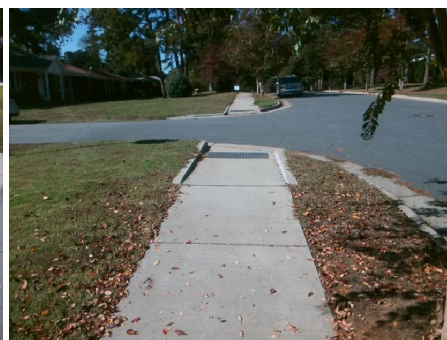
Not Found, R304.2.2-Perp, R304.3.2-Para, R305.1.4, R305.2

Compliance	Description	Data	Compliance	Description	Data
N/A	Ramp Length (in)	72.5	Yes	Grade Break?	Yes
Yes	Ramp Width (in)	58.0	Yes	Grade Break Slope (%)	1.9
Yes	Ramp Slope (%)	2.3	Yes	Grade Break XSlope (%)	0.6
Yes	Ramp XSlope (%)	0.4			
Yes	Flare Type LT	N/A	Yes	Flare Type RT	N/A
N/A	Flare Slope LT (%)	N/A	N/A	Flare Slope RT (%)	N/A
N/A	Flare Traversable LT?	No	N/A	Flare Traversable RT?	No
Yes	Landing Length (in)	66.0	Yes	DWS Provided?	Yes
Yes	Landing Width (in)	60.0	Yes	DWS Contrast?	Yes
No	Landing Slope (%)	8.6	Yes	DWS Length (in)	24.0
Yes	Landing X Slope (%)	0.9	No	DWS Full Width?	No
N/A	Landing Curb? (Y/N)	No	No	DWS Offset LT (in)	4.0
N/A	Shared Landing?	No	Yes	DWS Offset RT (in)	27.5
Yes	Gutter Ponding?	No	Yes	Gutter Slope (%)	4.3
Yes	Gutter Lip Ht (in)	0.0	Yes	Gutter X Slope (%)	0.7
N/A	Painted X Walk1?	No		Road Slope (%)	6.0
	X Walk 1 Direction	To NW		Road X Slope (%)	2.3
	X Walk 1 Width (in)	N/A		Clear Space?	Yes

X Walk 1 Slope (%)	6.0	N/A	Clear Space to XWalk (in)	N/A
	X Walk 1 X Slope (%)	2.3	Yes	Storm Grate/Utility Hazard?	No
N/A	Ramp inside XWalk1?	N/A		Storm Grate/Utility Type	
Yes	Any Obstructions?	No			N/A
	Obstruction Type		Yes	Surface Condition? (G/P)	Good
			N/A	Curb Slope (%)	18.9

Possible Solutions:

Remove & Replace Entire Ramp.
