# Access Compliance Report

## Public Rights-of-Way

### (Curb Ramps)

Intersection ID: 10034320	Main Street: PERIMETER_PY	Cross Street: N/A	Location:	SE
ADA ID: 5426AE1CCB24	Ramp Type: Perp	Initial Pass/Fail: Fail	Overall Compliance: No	Severity Score: 10
Codes/Mitigation Info/Possible Solution		Field Measurements/Component Compliance

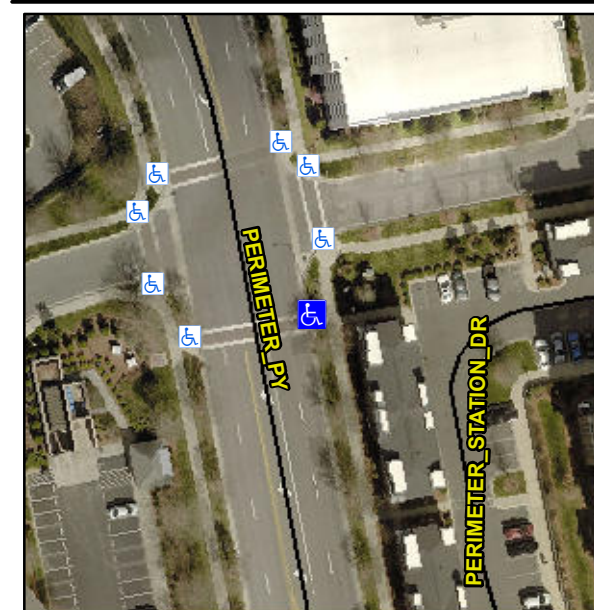
**Not Found, R304.5.1, R304.5.3**

Compliance	Description	Data	Compliance	Description	Data
N/A	Ramp Length (in)	96.0	Yes	Ramp Slope (%)	8.2
No	Ramp Width (in)	47.0	No	Ramp XSlope (%)	3.6
N/A	Flare Type LT	N/A	N/A	Flare Type RT	N/A
N/A	Flare Slope LT (%)	N/A	N/A	Flare Slope RT (%)	N/A
N/A	Flare Traversable LT?	N/A	N/A	Flare Traversable RT?	N/A
N/A	Landing Length (in)	N/A	N/A	DWS Provided?	N/A
N/A	Landing Width (in)	N/A	N/A	DWS Contrast?	N/A
N/A	Landing Slope (%)	N/A	N/A	DWS Length (in)	N/A
N/A	Landing X Slope (%)	N/A	N/A	DWS Full Width?	N/A
N/A	Landing Curb? (Y/N)	N/A	N/A	DWS Offset (in)	N/A
N/A	Shared Landing?	N/A			
N/A	Gutter Ponding?	N/A	N/A	Gutter Slope (%)	N/A
N/A	Gutter Lip Ht (in)	N/A	N/A	Gutter X Slope (%)	N/A
N/A	Painted X Walk1?	Yes	N/A	Painted X Walk2?	N/A
	X Walk 1 Direction	To W		X Walk 2 Direction	N/A
N/A	X Walk 1 Width (in)	72.0	N/A	X Walk 2 Width (in)	N/A
	X Walk 1 Slope (%)	1.3		X Walk 2 Slope (%)	N/A
	X Walk 1 X Slope (%)	3.4		X Walk 2 X Slope (%)	N/A

N/A	Ramp inside XWalk1?	Yes	N/A	Ramp inside XWalk2?	N/A
	Road Slope (%)	N/A	N/A	Clear Space?	N/A
	Road X Slope (%)	N/A	N/A	Clear Space to XWalk (in)	N/A
N/A	Any Obstructions?	N/A	N/A	Storm Grate/Utility Hazard?	N/A
	Obstruction Type			Storm Grate/Utility Type	
		N/A			N/A
			Yes	Surface Condition? (G/P)	Good

**Remove & Replace Entire Ramp.**
