Access Compliance Report

Public Rights-of-Way

(Curb Ramps)

Intersection ID: 10038507	Main Street: SPEER_BV	Cross Street: PIEDMONT_PARK_DR	Location: W
ADA ID: 543207D7DD03	Ramp Type: Directional1	Initial Pass/Fail: Fail	Overall Compliance: No
Severity Score: 12.5			
Codes/Mitigation Info/Possible Solution		Field Measurements/Component Compliance

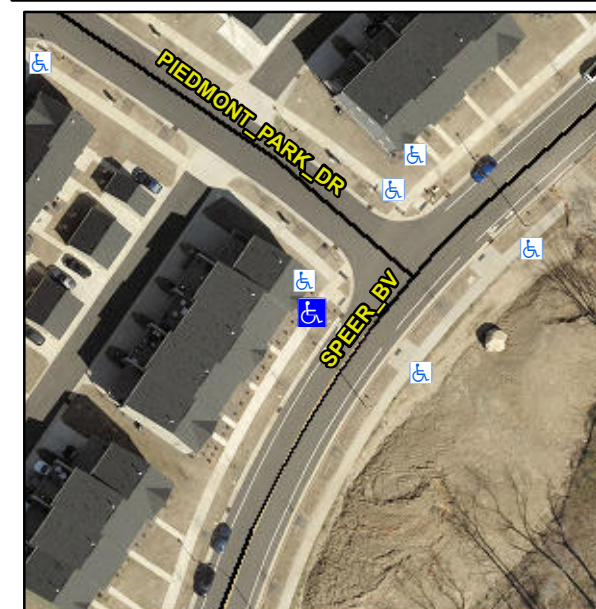
Compliance	Description	Data	Compliance	Description	Data
N/A	Ramp Length (in)	82.0	N/A	Grade Break?	N/A
Yes	Ramp Width (in)	69.0	N/A	Grade Break Slope (%)	0.0
No	Ramp Slope (%)	8.6	N/A	Grade Break XSlope (%)	0.0
Yes	Ramp XSlope (%)	1.9			
N/A	Flare Type LT	N/A	N/A	Flare Type RT	N/A
N/A	Flare Slope LT (%)	N/A	N/A	Flare Slope RT (%)	0.0
N/A	Flare Traversable LT?	N/A	N/A	Flare Traversable RT?	N/A
N/A	Landing Length (in)	0.0	N/A	DWS Provided?	N/A
N/A	Landing Width (in)	0.0	N/A	DWS Contrast?	N/A
N/A	Landing Slope (%)	0.0	N/A	DWS Length (in)	N/A
N/A	Landing X Slope (%)	0.0	N/A	DWS Full Width?	N/A
N/A	Landing Curb? (Y/N)	N/A	N/A	DWS Offset LT (in)	N/A
N/A	Shared Landing?	N/A	N/A	DWS Offset RT (in)	N/A
N/A	Gutter Ponding?	0.0	N/A	Gutter Slope (%)	N/A
N/A	Gutter Lip Ht (in)	0.0	N/A	Gutter X Slope (%)	N/A
N/A	Painted X Walk1?	No		Road Slope (%)	3.3
	X Walk 1 Direction	To SE		Road X Slope (%)	1.4
	X Walk 1 Width (in)	N/A		Clear Space?	N/A

X Walk 1 Slope (%)	3.3	N/A	Clear Space to XWalk (in)	N/A
	X Walk 1 X Slope (%)	1.4	N/A	Storm Grate/Utility Hazard?	N/A
N/A	Ramp inside XWalk1?	N/A		Storm Grate/Utility Type	
N/A	Any Obstructions?	N/A			N/A
	Obstruction Type		Yes	Surface Condition? (G/P)	Good
			N/A	Curb Slope (%)	7.9

Possible Solutions:

Remove & Replace Entire Ramp.
