Access Compliance Report

Public Rights-of-Way

(Curb Ramps)

Intersection ID: 3823	Main Street: BROWNE'S_FERRY_RD	Cross Street: CORNERSTONE_DR	Location: NE
ADA ID: 543D731B4B70	Ramp Type: Perpendicular	Initial Pass/Fail: Fail	Overall Compliance: No
		Severity Score: 8.75

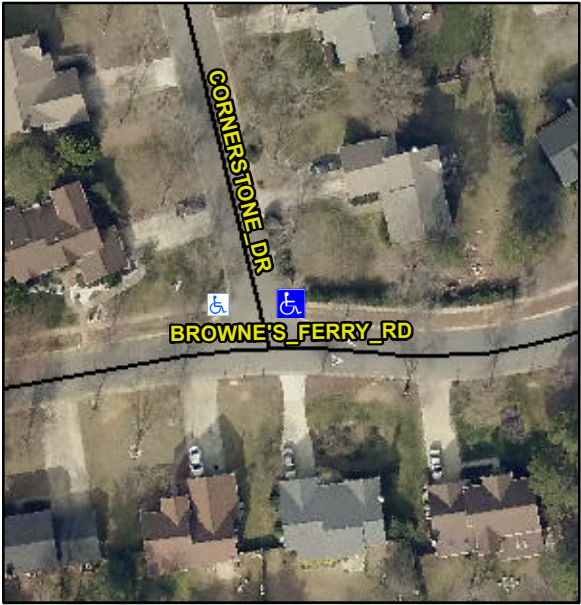
Possible Solutions:		Compliance	Description	Data
	Remove & Replace Entire Ramp.		Yes	Ramp Length (in)	46.5
			No	Ramp Width (in)	47.0
			N/A	Flare Type LT	N/A
			N/A	Flare Slope LT (%)	N/A
			N/A	Flare Traversable LT?	N/A
			N/A	Landing Length (in)	N/A
			N/A	Landing Width (in)	N/A
			N/A	Landing Slope (%)	N/A
			N/A	Landing X Slope (%)	N/A
			N/A	Landing Curb? (Y/N)	N/A
			N/A	Shared Landing?	N/A
			N/A	Gutter Ponding?	N/A
			N/A	Gutter Lip Ht (in)	N/A
			No	Painted X Walk1?	N/A
			To W	X Walk 1 Direction	N/A
			N/A	X Walk 1 Width (in)	N/A

3.4	X Walk 1 Slope (%)	N/A
			3.0	X Walk 1 X Slope (%)	N/A
			N/A	Ramp inside XWalk1?	N/A
<p>Surveyor Notes:</p> <p>N/A</p> <p>PROW/ADA:</p> <p>R304.5.1</p>			N/A	Flare Type RT	N/A
			N/A	Flare Slope RT (%)	N/A
			N/A	Flare Traversable RT?	N/A
			N/A	DWS Provided?	N/A
			N/A	DWS Contrast?	N/A
			N/A	DWS Length (in)	N/A
			N/A	DWS Full Width?	N/A
			N/A	DWS Offset (in)	N/A
			N/A	Gutter Slope (%)	N/A
			N/A	Gutter X Slope (%)	N/A
			N/A	Painted X Walk2?	N/A
			N/A	X Walk 2 Direction	N/A
			N/A	X Walk 2 Width (in)	N/A
			N/A	X Walk 2 Slope (%)	N/A
			N/A	X Walk 2 X Slope (%)	N/A
			N/A	Ramp inside XWalk2?	N/A
			N/A	Clear Space?	N/A
			N/A	Clear Space to XWalk (in)	N/A
			N/A	Storm Grate/Utility Hazard?	N/A
			N/A	Storm Grate/Utility Type	N/A
<p>Total Cost:</p> <p>\$ 1850.00</p>			N/A		N/A
			Yes	Surface Condition? (G/P)	Good
