Access Compliance Report

Public Rights-of-Way

(Curb Ramps)

Intersection ID: 12344	Main Street: REMOUNT_RD	Cross Street: GREENLAND_AV	Location: NW
ADA ID: 544246A901B6	Ramp Type: Perp	Initial Pass/Fail: Fail	Overall Compliance: No
		Severity Score: 8.75

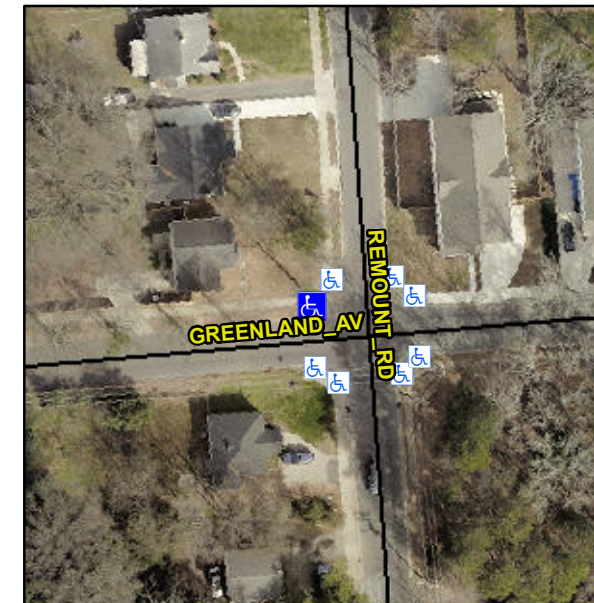
Not Found, R304.5.1

Compliance	Description	Data	Compliance	Description	Data
N/A	Ramp Length (in)	67.5	Yes	Ramp Slope (%)	7.3
No	Ramp Width (in)	47.5	Yes	Ramp XSlope (%)	1.9
N/A	Flare Type LT	N/A	N/A	Flare Type RT	N/A
N/A	Flare Slope LT (%)	N/A	N/A	Flare Slope RT (%)	N/A
N/A	Flare Traversable LT?	N/A	N/A	Flare Traversable RT?	N/A
N/A	Landing Length (in)	N/A	N/A	DWS Provided?	N/A
N/A	Landing Width (in)	N/A	N/A	DWS Contrast?	N/A
N/A	Landing Slope (%)	N/A	N/A	DWS Length (in)	N/A
N/A	Landing X Slope (%)	N/A	N/A	DWS Full Width?	N/A
N/A	Landing Curb? (Y/N)	N/A	N/A	DWS Offset (in)	N/A
N/A	Shared Landing?	N/A			
N/A	Gutter Ponding?	N/A	N/A	Gutter Slope (%)	N/A
N/A	Gutter Lip Ht (in)	N/A	N/A	Gutter X Slope (%)	N/A
N/A	Painted X Walk1?	No	N/A	Painted X Walk2?	N/A
	X Walk 1 Direction	To S		X Walk 2 Direction	N/A
N/A	X Walk 1 Width (in)	N/A	N/A	X Walk 2 Width (in)	N/A
	X Walk 1 Slope (%)	0.4		X Walk 2 Slope (%)	N/A
	X Walk 1 X Slope (%)	2.7		X Walk 2 X Slope (%)	N/A

Remove & Replace Entire Ramp.
