# Access Compliance Report

## Public Rights-of-Way

| Intersection ID: 13086 | Main Street: CENTRAL_AV | Cross Street: CLEMENT_AV | Location: SW |
| ADA ID: 5456E54BCC30 | Ramp Type: Directional2 | Initial Pass/Fail: Pass | Overall Compliance: No |

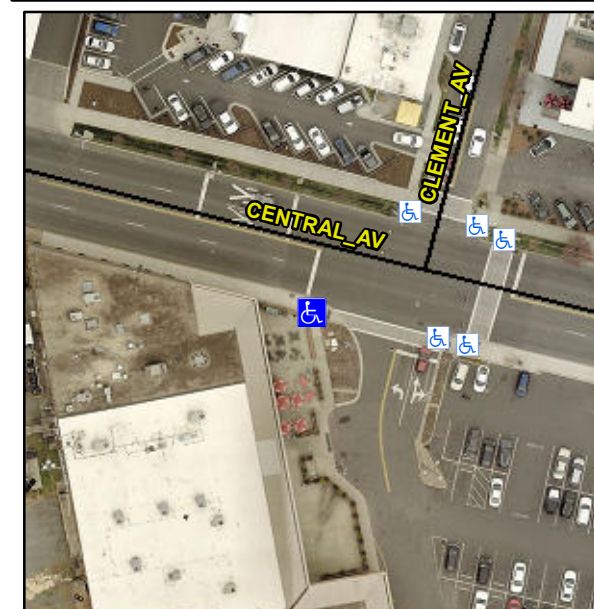
**R304.2.2, R304.2.2-Perp, R304.3.2-  
Para, R305.2, R304.5.3**

| Compliance | Description | Data | Compliance | Description | Data |
|---|---|---|---|---|---|
| No | Ramp Slope (%) | 0.0 | Yes | Grade Break XSlope (%) | 1.1 |
| No | Landing Slope (%) | 2.4 | Yes | DWS Length (in) | 24.0 |
| N/A | Landing Curb? (Y/N) | No | No | DWS Offset LT (in) | 97.0 |
| Yes | Gutter Lip Ht (in) | 0.0 | No | Gutter X Slope (%) | 2.7 |

**Remove & Replace Entire Ramp.  
Remove & Replace Gutter.**
