# Access Compliance Report

## Public Rights-of-Way

Intersection ID: 19406	Main Street: SOUTH_BV	Cross Street: BOURBON_ST	Location: SW
ADA ID: 545AD2C509C6	Ramp Type: Perp	Initial Pass/Fail: Fail	Overall Compliance: No
Severity Score: 37.5			
Codes/Mitigation Info/Possible Solution		Field Measurements/Component Compliance

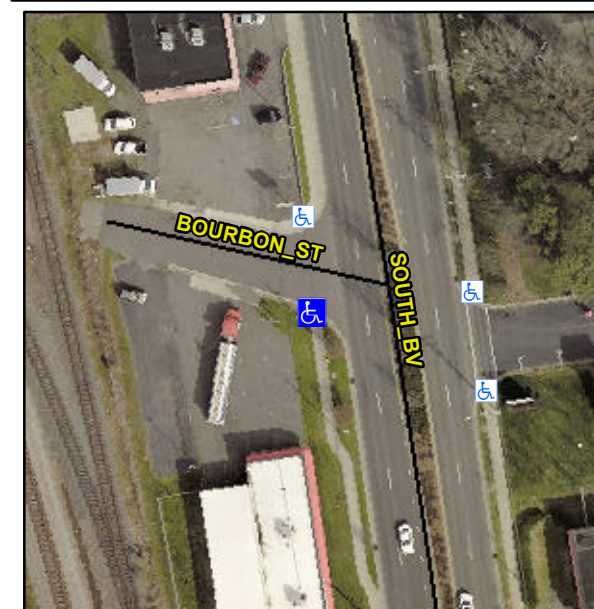
**Not Found, R304.2.2, R304.5.3**

Compliance	Description	Data	Compliance	Description	Data
N/A	Ramp Length (in)	74.0	No	Ramp Slope (%)	10.9
Yes	Ramp Width (in)	48.0	No	Ramp XSlope (%)	7.1
N/A	Flare Type LT	N/A	N/A	Flare Type RT	N/A
N/A	Flare Slope LT (%)	N/A	N/A	Flare Slope RT (%)	N/A
N/A	Flare Traversable LT?	N/A	N/A	Flare Traversable RT?	N/A
N/A	Landing Length (in)	N/A	N/A	DWS Provided?	N/A
N/A	Landing Width (in)	N/A	N/A	DWS Contrast?	N/A
N/A	Landing Slope (%)	N/A	N/A	DWS Length (in)	N/A
N/A	Landing X Slope (%)	N/A	N/A	DWS Full Width?	N/A
N/A	Landing Curb? (Y/N)	N/A	N/A	DWS Offset (in)	N/A
N/A	Shared Landing?	N/A			
N/A	Gutter Ponding?	N/A	N/A	Gutter Slope (%)	N/A
N/A	Gutter Lip Ht (in)	N/A	N/A	Gutter X Slope (%)	N/A
N/A	Painted X Walk1?	No	N/A	Painted X Walk2?	N/A
	X Walk 1 Direction	To N		X Walk 2 Direction	N/A
N/A	X Walk 1 Width (in)	N/A	N/A	X Walk 2 Width (in)	N/A
	X Walk 1 Slope (%)	0.4		X Walk 2 Slope (%)	N/A
	X Walk 1 X Slope (%)	6.7		X Walk 2 X Slope (%)	N/A

**Remove & Replace Entire Ramp.**

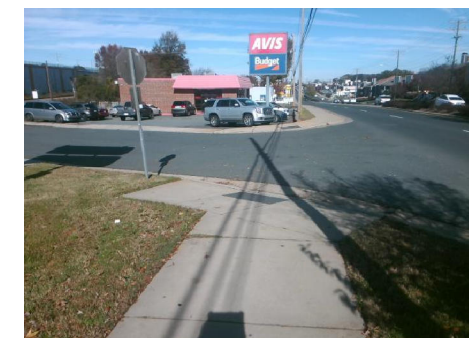
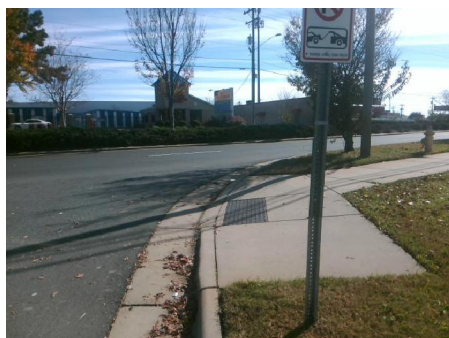
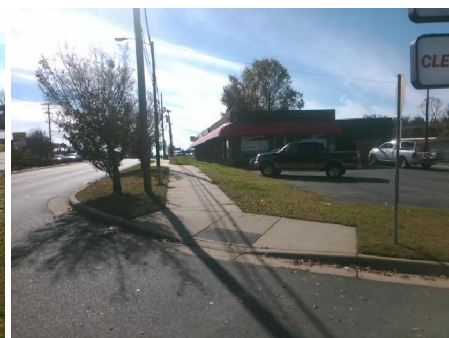
N/A	Ramp inside XWalk1?	N/A	N/A	Ramp inside XWalk2?	N/A
	Road Slope (%)	N/A	N/A	Clear Space?	N/A
	Road X Slope (%)	N/A	N/A	Clear Space to XWalk (in)	N/A
N/A	Any Obstructions?	N/A	N/A	Storm Grate/Utility Hazard?	N/A
	Obstruction Type			Storm Grate/Utility Type	
		N/A			N/A
			Yes	Surface Condition? (G/P)	Good

Street 1 Name	BOURBON ST
Stop Condition-Street 2	None
Street 2 Name	N/A
Stop Condition-Street 1	N/A
