## Access Compliance Report Public Rights-of-Way (Curb Ramps)

Intersection ID: 16526 Main Street: AMITY\_PL Cross Street: ASPENDALE\_LN Location: SE

ADA ID: 545C1C3AF9EC Ramp Type: PerpDiag Initial Pass/Fail: Fail Overall Compliance: No Severity Score: 1.25

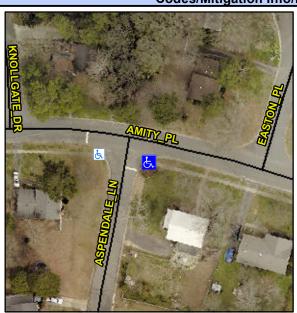
Not Found, R304.5.3

Field Measurements/Component Compliance						
Compliance Description		Data	Comp	liance	Description	Data
N/A	Ramp Length (in)	58.0	Yes	Ramp	Slope (%)	5.7
Yes	Ramp Width (in)	48.0	No	Ramp	XSlope (%)	4.9
N/A	Flare Type LT	N/A	N/A	Flare <sup>-</sup>	Type RT	N/A
N/A	Flare Slope LT (%)	N/A	N/A	Flare	Slope RT (%)	N/A
N/A	Flare Traversable LT?	N/A	N/A	Flare <sup>-</sup>	Traversable RT?	N/A
N/A	Landing Length (in)	N/A	N/A	DWS	Provided?	N/A
N/A	Landing Width (in)	N/A	N/A	DWS	Contrast?	N/A
N/A	Landing Slope (%)	N/A	N/A	DWS	Length (in)	N/A
N/A	Landing X Slope (%)	N/A	N/A	DWS	Full Width?	N/A
N/A	Landing Curb? (Y/N)	N/A	N/A	DWS	Offset (in)	N/A
N/A	Shared Landing?	N/A				
N/A	Gutter Ponding?	N/A	N/A	Gutter	Slope (%)	N/A
N/A	Gutter Lip Ht (in)	N/A	N/A	Gutter	X Slope (%)	N/A
N/A	Painted X Walk1?	No	N/A	Painte	ed X Walk2?	No
	X Walk 1 Direction	To N		X Wall	k 2 Direction	To NW
N/A	X Walk 1 Width (in)	N/A	N/A	X Wall	k 2 Width (in)	N/A

X Walk 1 Slope (%)	6.9		X Wall	k 2 Slope (%)	5.0
	X Walk 1 X Slope (%)	4.9		X Wall	k 2 X Slope (%)	4.7
N/A	Ramp inside XWalk1?	N/A	N/A	Ramp	inside XWalk2?	N/A
	Road Slope (%)	4.6	N/A	Clear	Space?	N/A
	Road X Slope (%)	6.5	N/A	Clear	Space to XWalk (in)	N/A
N/A	Any Obstructions?	N/A	N/A	Storm	Grate/Utility Hazard?	N/A
	Obstruction Type			Storm	Grate/Utility Type	
		N/A				N/A
			Yes	Surfac	ce Condition? (G/P)	Good

Remove & Replace Curb Ramp With
Two New Directional Ramps or
Equivalent.
