Access Compliance Report

Public Rights-of-Way

(Curb Ramps)

Intersection ID: 49400	Main Street: OLD_CONCORD_RD	Cross Street: LAUREN_VILLAGE_DR	Location: W
ADA ID: 545D46ED6117	Ramp Type: Perp	Initial Pass/Fail: Fail	Overall Compliance: No
Severity Score: 8.75			
Codes/Mitigation Info/Possible Solution		Field Measurements/Component Compliance

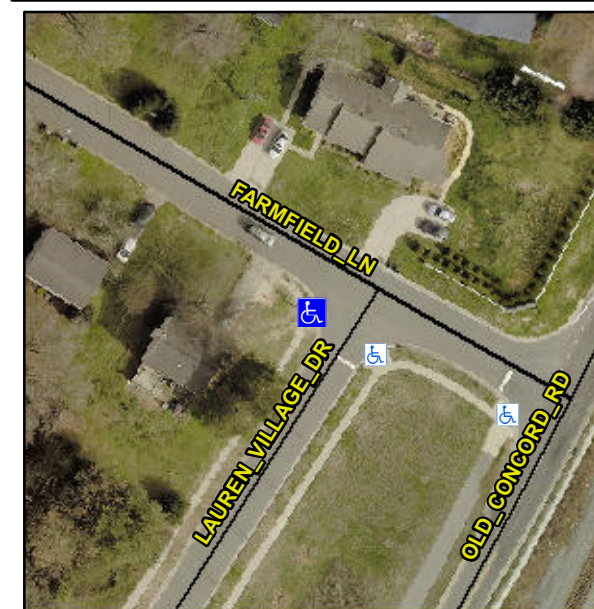
Not Found, R304.5.1

Compliance	Description	Data	Compliance	Description	Data
N/A	Ramp Length (in)	52.0	Yes	Ramp Slope (%)	5.7
No	Ramp Width (in)	47.0	Yes	Ramp XSlope (%)	1.9
N/A	Flare Type LT	N/A	N/A	Flare Type RT	N/A
N/A	Flare Slope LT (%)	N/A	N/A	Flare Slope RT (%)	N/A
N/A	Flare Traversable LT?	N/A	N/A	Flare Traversable RT?	N/A
N/A	Landing Length (in)	N/A	N/A	DWS Provided?	N/A
N/A	Landing Width (in)	N/A	N/A	DWS Contrast?	N/A
N/A	Landing Slope (%)	N/A	N/A	DWS Length (in)	N/A
N/A	Landing X Slope (%)	N/A	N/A	DWS Full Width?	N/A
N/A	Landing Curb? (Y/N)	N/A	N/A	DWS Offset (in)	N/A
N/A	Shared Landing?	N/A			
N/A	Gutter Ponding?	N/A	N/A	Gutter Slope (%)	N/A
N/A	Gutter Lip Ht (in)	N/A	N/A	Gutter X Slope (%)	N/A
N/A	Painted X Walk1?	No	N/A	Painted X Walk2?	N/A
	X Walk 1 Direction	To S		X Walk 2 Direction	N/A
N/A	X Walk 1 Width (in)	N/A	N/A	X Walk 2 Width (in)	N/A
	X Walk 1 Slope (%)	2.1		X Walk 2 Slope (%)	N/A
	X Walk 1 X Slope (%)	4.4		X Walk 2 X Slope (%)	N/A

N/A	Ramp inside XWalk1?	N/A	N/A	Ramp inside XWalk2?	N/A
	Road Slope (%)	N/A	N/A	Clear Space?	N/A
	Road X Slope (%)	N/A	N/A	Clear Space to XWalk (in)	N/A
N/A	Any Obstructions?	N/A	N/A	Storm Grate/Utility Hazard?	N/A
	Obstruction Type			Storm Grate/Utility Type	
		N/A			N/A
			Yes	Surface Condition? (G/P)	Good

Possible Solutions:

Remove & Replace Entire Ramp.
